# Analysis on Fault Failure of Automatic Meter Reading System on Hardware Devices

The Automatic Meter Reading (AMR) system is an indirect measurement system used by PT PLN (Persero) to facilitate the monitoring of customer electricity usage. Electricity usage measurements determine the revenue of electricity providers. Manual data reading errors and device malfunctions are the main complaints customers have against electricity providers. The AMR system has been implemented for many customers, and its presence can reduce irregularities. Irregularities that occur in AMR can generally be divided into two types, namely irregularities due to serial communication failures that need to be repaired, and technical irregularities where energy is not measured optimally. The use of the FMEA analysis method is expected to identify, determine, reduce, and eliminate failures and potential failures from the process before these failures reach customers. Based on the FMEA analysis results, corrective actions in the form of hardware replacement on components with the highest Risk Priority Number (RPN) proved effective in reducing the RPN value after the repairs were made, thereby increasing the rel

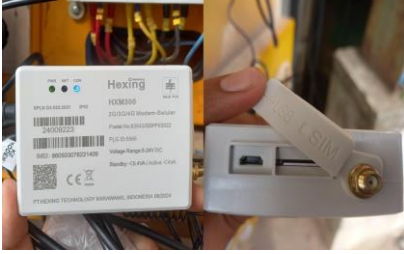
<p>The AMR EDMI modem uses an 8-pin Micro-Fit connector and SMA Female, but does not have a USB port, status indicator, or environmental protection. Its configuration is manual and impractical for maintenance.</p>
<p style="text-align: center;"><b>NEW MODEM</b> (Hexing HXM 300)</p>

Based on the table above, it explains the differences between the old and new devices used by PT PLN according to the analysis results. The AMR EDMI modem is an older generation device used in the Automatic Meter Reading (AMR) system, which functions to send meter data to a central location via a cellular communication network. Although it still works well for some applications, this modem has several weaknesses that affect its efficiency and reliability in the field.

- Does not have a USB port  
The EDMI modem only has an 8-pin Micro-Fit data connector, without support for a standard USB port. This means that manual data retrieval or device configuration must be done using a special cable and adapter. For field technicians, this makes troubleshooting difficult because it cannot be directly connected to a computer or laptop.
- Not Equipped with LED Indicator  
This modem does not have status indicator lights to show conditions such as power, signal, or data activity. As a result, technicians cannot immediately tell whether the modem is functioning normally, connected to the network, or experiencing interference without the aid of additional measuring instruments.
- Antenna Connectors Prone to Loosening  
The SMA Female antenna connector on EDMI modems can easily become loose if frequently

disconnected and reconnected. This condition can cause unstable signals, or even signal loss, especially in areas with high vibration or exposure to the outside environment. In the long term, this has the potential to reduce the quality of AMR data communication.

<p>Hexing AMR modem complies with PLN standards with 2G/3G/4G support, USB port, LED status indicator, easily accessible SIM slot, and strong antenna connector for stable connection..</p>
