Failure Analysis of Econo Dual Module Frame Installation in The Automatic Frame Assembly Process

FINAL PROJECT PROPOSAL

**Electronics Manufacturing Engineering Study Program
Department of Electrical Engineering
Batam State Polytechnic
2023**

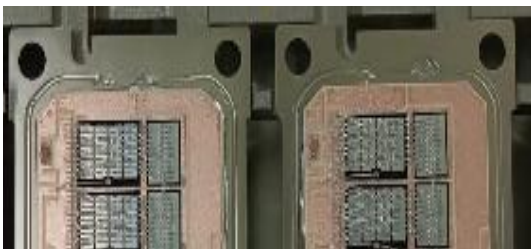
Gluing is one of the causes of frame installation failure because gluing is an adhesive material between the module and the frame. If there is a problem with the adhesive material then of course the level of adhesion of the frame and modules will be very weak and easily separated, then the frame installation process can be said to have failed. Therefore, when there is a gluing error on the module, the robot will automatically detect it and not install the frame on the module. The gluing error that usually occurs most often is that the gluing is not connected completely at the edge of the module, and other gluing errors that occur are bubbles in the gluing and messy or irregular gluing.

Figure 5. Discontinuity Gluing

After the author investigated for several months, it turned out that the cause of the machine often experiencing gluing discontinuities was the condition of the needle used in the gluing machine. Sometimes the gluing that comes out of the needle doesn't come out smoothly in the needle hole, so there are parts of the edge of the module that are not gluing or the gluing on the module is not connected completely or what is called a discontinuity gluing. Likewise, the cause of bubbles is also caused by the condition of the needle hole which produces gluing with small bubbles at several points. So the solution that can be done is to routinely check the needle first every time you want to use the machine to find out whether the needle is experiencing obstacles in removing the gluing in the hole or whether there are bubbles in the gluing, and immediately report to the shiftleader to ask for technician/maintenance help to clean the needle. If there is only dirt in the needle hole, it is still possible that the needle can be used. And if necessary, the needle is immediately replaced with a new needle if the previous needle is no longer suitable for use.

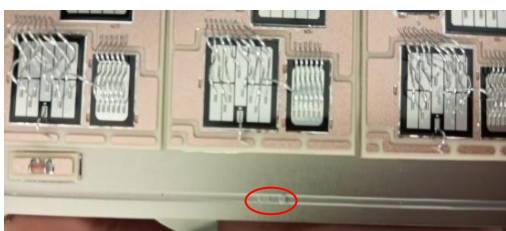
Figure 6. Bubble

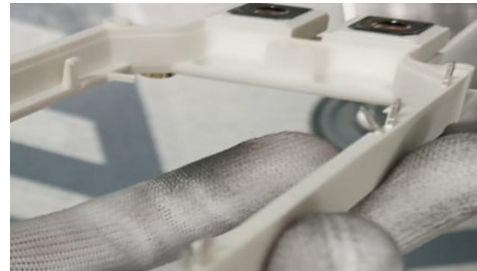
Damage to the frame that occurs is usually characterized by bent or broken frame pins which causes the robot to automatically detect via the camera sensor that the frame is defective or a frame that does not meet the frame specifications and discards the frame due to a fairly hard collision between the frames. with the frame container in the frame box before being put into the machine or the frame container colliding with the small trolley (as a place for the frame container to run on the machine) when inserting the frame container into the small trolley, resulting in defects in the frame in the frame container.

Figure 7. Bent Pin

In solving this problem, it took almost 2 months, before the author was able to find a solution to minimize this problem, because this was the last problem to be prioritized, because this was the problem that occurred the least compared to other problems. Bent frame pins occur due to a collision or friction of another object against the frame pin which causes the frame pin to become bent. This is because the pin frame is very sensitive and bends easily. Therefore, the author coordinates with the person in charge of quality materials to check whether all the frames used are in good condition, and of course the author checks again before putting them into the machine to ensure that the condition of the frames used is in good condition and that there are no bent pins. , and also be more careful when you want to insert the frame into the machine so that there are no hits/collisions on the frame pins.

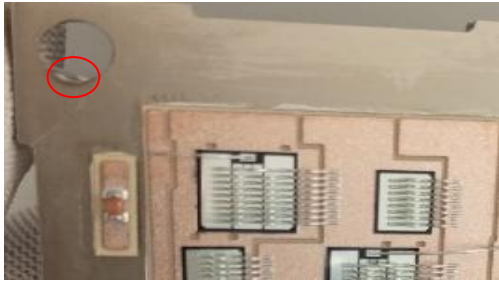
The presence of solder spatter in the baseplate hole causes the baseplate hole to limit the entry space for the corner of the frame hole to the baseplate hole. So when the machine detects solder spatter in the baseplate hole, the frame cannot be attached to the module. Solder splatter not only occur in the baseplate holes, sometimes they also occur on the DCB. But this does not mean that the frame is not attached to the module, it remains attached to the module. However, the module is already a reject, because the solder spatter on the module does not fulfill the standard product specifications that have been determined.

Figure 10. Solder Spatter

Dealing with solder spatter problems is more or less the same as dealing with NTC Missing. This is due to checking the module first whether the module is in good condition or not, and coordinating with the operator operating in the soldering system process, because the causes of solder spatter and NTC Missing defects come from the soldering system process. The only difference is that if the NTC defect is missing, what is checked is whether the NTC is on the module or not, whereas if the defect is solder spatter, what is checked is whether there is solder spatter on the DCB or in the hole in the baseplate. When a module that has solder spatter on the DCB is run on the machine, the frame will remain attached to the module, but the module is still a reject, because modules that comply with standard product specifications must not have solder spatter. Meanwhile, if a module that has solder spatter in the baseplate hole is run on the machine, of course the frame cannot be attached to the module because the baseplate hole limits the entry space for the corners of the frame to the baseplate hole so the frame will not be able to be attached to the module because of the solder spatter in the baseplate hole.
