# **Analysis of Lifted Metal Defect Improvement at Wire Bond Process for iMOTION Device**

## **Final Project**

**Nada Rindiani Susanto (3222101012)**

**Politeknik Negeri Batam**

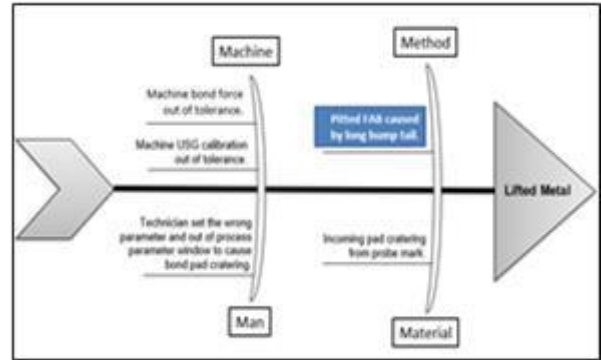
Figure 3 Fishbone Diagram

No	Factor	Reason	Verification Methode	Verification Result
1	Man	Technician set the wrong parameter and out of process parameter window to cause bond pad cratering.	Check parameter setting.	No different from the comparison
2	Machine	Machine bond force out of tolerance.	Check the bond force with bond force calibration jig.	Lifted metal remain after the calibration. It is not the root cause.
		Machine USG calibration out of tolerance.	Check the UCAC calibration value.	Within calibration spec limit for +/- 30%. It is not the root cause.
3	Method	Pitted FAB caused by long bump tail.	Repeat check with long bump tail condition with Hi-SC.	Lifted metal observed with long bump tail unit.
4	Material	Incoming pad cratering from probe mark.	Check bond pad probe mark. Submit the unbonded unit for FA check.	No cratering with 20units of inspection. It is not the root cause.

The raised metal is visible when there is an asymmetrical FAB that forms a long bump tail. The failure is an incomplete FAB, tailing at bump causes an initial crack in the bonding pad. The crack propagates to the pad surface and weakens the top metal layer of the pad. Hence, the metal lifted off during loop formation.

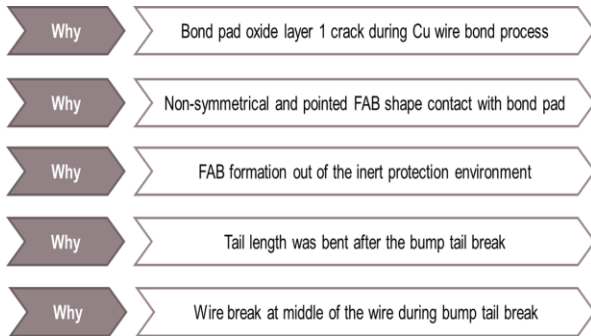
Figure 4 Why-why Analysis

The use of why-why analysis here is to analyze the root of the problem in the context of problem solving, i.e. looking for the root of a problem that has been observed. Here, the why-why analysis looks for the root cause of the tailing bump causing lifted metal.

From the why-why analysis on tailings bump, it is Optimized the bump tail break to improve the tailing at bump on lead.

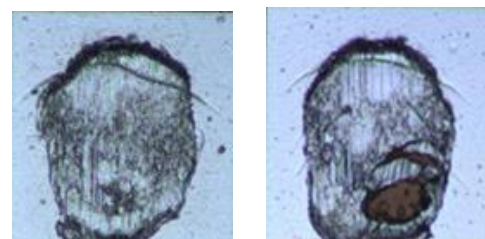
Figure 5 SEM Measuring Result

The photo results obtained using the SEM inspection tool show that the metal is lifted from the top view of the pad at first bonding. Seen in the picture below in the left picture for good and the right for not good.

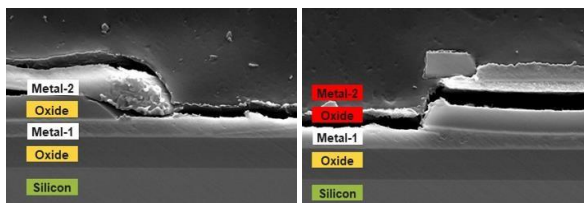
Figure 4 Electron Microscope Measuring Result

But the results of measuring instruments that are only seen from the top view are not enough to prove whether this defect is accepted or not to see the accept criteria on the chip, the results are needed to look inside. This is useful to see whether this lifted metal reaches metal layer 1 on the chip or not. To see the results of the inside view, an electron microscope inspection tool is needed.

After being seen using an electron microscope measuring instrument, you can see the lifted metal on the chip. Lifted metal cannot only be seen from the top view only. because the condition of this lifted metal is that if the chip has not been chipped until it reaches silicon or metal 1 on the chip, it is still said to be acceptable. However, if it has been exposed to metal 1 and has reached the silicon, it is said to be defective. Inspection of the inside of the chip is needed to see the success of this defect whether the chip meets the criteria or not.
