# **Identification and Prioritization of Component Failure Risks in the Electrical System at the As Salam Mosque Using the FMEA Approach**

## **Final Project**

**Electronics Manufacturing Engineering Study Program  
Electrical Engineering Department  
Politeknik Negeri Batam  
2026**

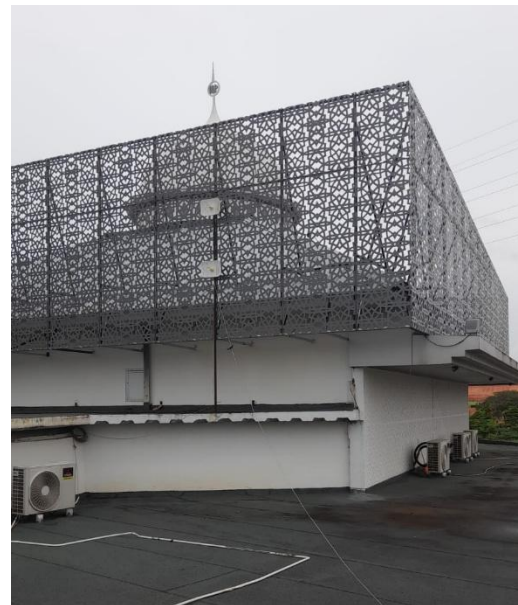
Figure 3. Roof Lighting Near the Mosque Dome

Figure 3 shows the lighting system installed on the ceiling near the mosque's dome. The installation location is at a considerable height with limited access, making the inspection, maintenance, and replacement of the lights more difficult. These conditions increase maintenance time and the risk of failures that could affect the reliability of the lighting system.

The Severity (S) assessment indicates that the lighting system has moderate to high consequences when failures occur. The highest Severity value (9) is assigned to the roof lighting near the mosque dome because maintenance activities are difficult due to the elevated installation location. Failure of this lighting system may reduce illumination in an important area of the mosque while delaying repair activities.

The Occurrence (O) values range from 5 to 7, indicating that failures occur with moderate frequency. The highest Occurrence value (7) is associated with the roof lighting near the mosque dome, where maintenance is often delayed because of difficult access.

Based on the FMEA analysis, the roof lighting near the mosque dome has the highest RPN value (378), indicating that it is the highest priority for improvement because its elevated location makes inspection and maintenance difficult. The garden and parking lighting has the second highest RPN (288) due to continuous exposure to outdoor weather conditions.

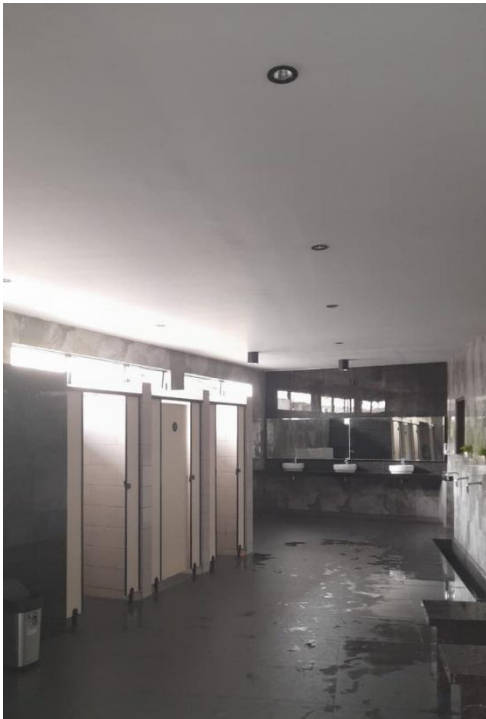
Figure 4. Mosque toilet lights

Figure 4 shows the lighting system installed in the mosque's restroom area. The humid environment and limited ventilation increase the likelihood of moisture entering the electrical components, which can accelerate component failure and reduce the reliability of the lighting system.

The toilet lighting system has an RPN value of 240, mainly because high humidity can reduce the reliability of electrical components. The terrace lighting system has an RPN value of 175, indicating a moderate risk that can be minimized through routine inspection and maintenance. Meanwhile, the lighting control panel has the lowest RPN value (160), but preventive maintenance is still necessary to ensure stable operation.

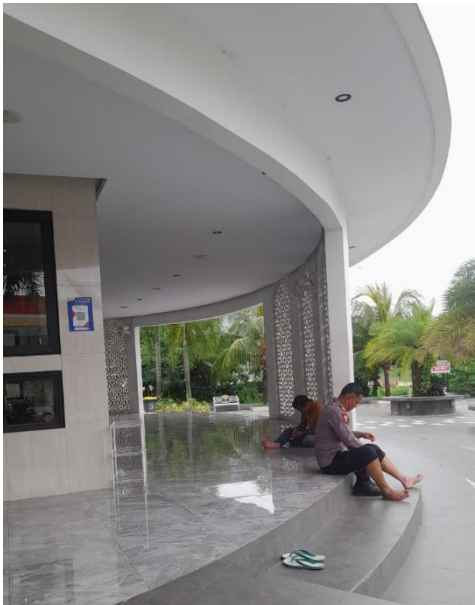
Figure 5. Mosque terrace lights

Figure 5 shows the lighting system installed on the mosque's terrace, which is directly exposed to outdoor environmental conditions. Constant exposure to sunlight, rain, dust, and temperature fluctuations can accelerate the deterioration of components and increase the risk of damage to the lighting system.

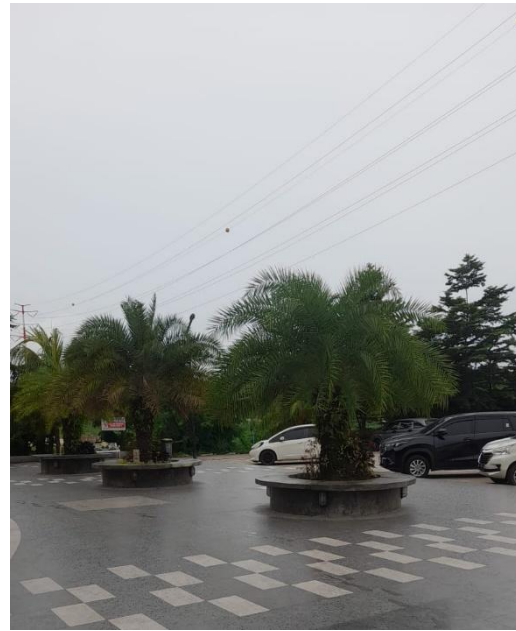
Figure 6. Mosque garden and parking lights

Figure 6 shows the lighting system installed in the mosque's garden and parking lot areas. The lights are spread across a fairly large outdoor area and operate for long periods at night. Exposure to environmental conditions and the vastness of the installation area make inspection and maintenance more challenging, thereby increasing the likelihood of malfunctions that could affect lighting quality and user safety.
