# ANALYSIS OF TOP MIRROR VISION BROKEN IN TSP (TEST SCAN PACK) MACHINE

Alif Restu Dwi Putra<sup>1</sup>, Vivin Octowinandi, S.Tr.T., M.Sc.<sup>1</sup>

<sup>1</sup>Jurusan Teknik Elektro, Prodi Teknik Elektronika Manufaktur, Politeknik Negeri Batam, Batam, Indonesia

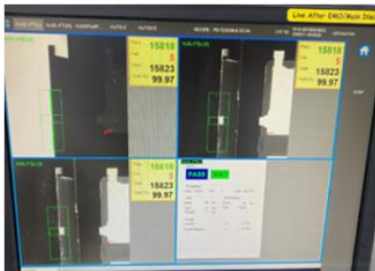
Figure 3. Top Mirror Vision in Good Condition

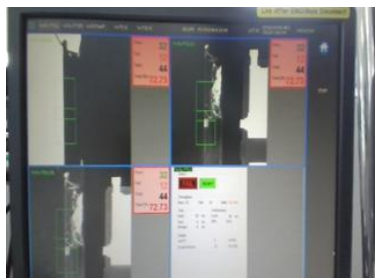
The condition of the Top Mirror Vision directly affects the quality of the inspection image captured by the camera. When the mirror is in good condition, the reflected image remains clear and stable, allowing the inspection system to accurately detect and classify products. The inspection result obtained under this condition is shown in Figure 3. However, when the mirror surface is damaged, the reflection quality decreases, resulting in blurry images, noise, and inaccurate detection by the inspection system. This condition may lead to invalid rejects and reduced inspection reliability. The inspection result under a damaged Top Mirror Vision condition is shown in Figure 4.

Figure 4. Top Mirror Vision in Broken Condition

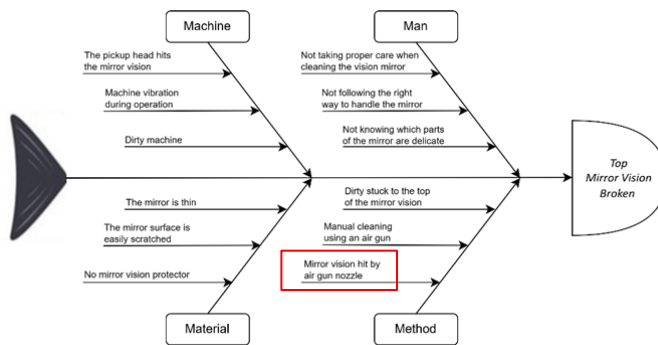
Figure 7. Fishbone Diagram of Top Mirror Vision Broken

Based on the validation results, the lack of a fixed nozzle position and distance control during manual cleaning was identified as the primary root cause. Since the nozzle position depended entirely on the operator, the nozzle could be positioned inconsistently and potentially enter the Top Mirror Vision area, increasing the risk of accidental contact with the mirror surface. This condition may result in physical damage, such as scratches or cracks, which can degrade inspection performance.

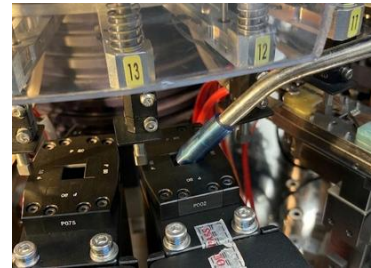
Figure 8. Air Gun Nozzle Inserted into the Top Mirror Vision Area During Cleaning

Figure 8 shows the manual cleaning process where the air gun nozzle was inserted into the Top Mirror Vision area to clean the mirror surface. Since no fixed nozzle position or distance control was provided, this cleaning method increased the potential risk of accidental contact with the mirror.

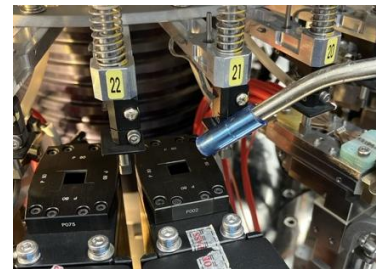
Figure 9. Air Gun Nozzle Positioned Outside the Top Mirror Vision Area During Cleaning

Figure 9 shows the manual cleaning process where the air gun nozzle remained outside the Top Mirror Vision area. This nozzle position reduced the possibility of accidental contact with the mirror surface during cleaning.

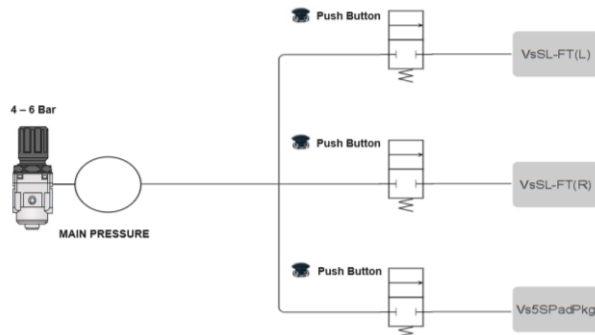
Figure 10. Semi-Automated Cleaning System Design

The system uses a 4–6 bar air pressure distributed to multiple inspection points. Each line is controlled by a push button to direct airflow to specific cameras. When activated, the airflow cleans the Top Mirror Vision without direct contact, ensuring a safer and more consistent cleaning process.

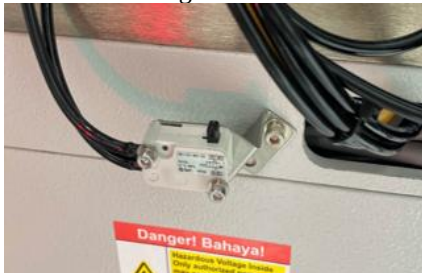
Figure 11. Implementation of Semi-Automated Cleaning System

The semi-automated cleaning system was implemented on the TSP machine to replace the previous manual cleaning method, which had a high risk of direct contact with the Top Mirror Vision surface. The semi-automated cleaning system utilizes compressed air distributed through pneumatic tubing and operated using a push-button mechanism [8]. The system utilizes controlled airflow distributed through several inspection points using push button control valves. This implementation was designed to improve cleaning consistency, reduce operator-related risks, and minimize the possibility of physical damage during the cleaning process. The implementation of the semi-automated cleaning system on the TSP machine is shown in Figure 11.

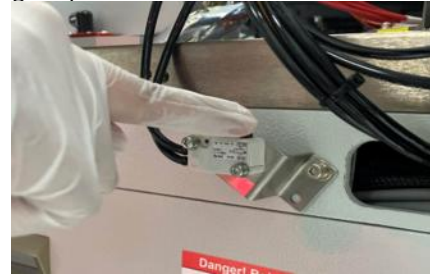
Figure 13. Push Button Cleaning System Operation

During operation, the operator activates the push button to release compressed air toward the Top Mirror Vision surface without direct contact. This mechanism allows contaminants on the mirror surface to be removed safely while maintaining a consistent cleaning process. The operation of the cleaning system using the push-button mechanism is shown in Figure 13.

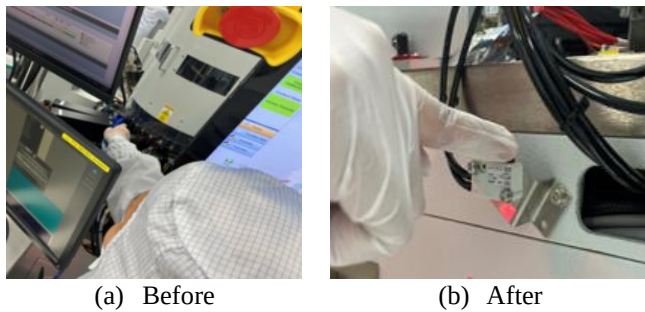
The implementation of the semi-automated cleaning system minimizes direct contact between the cleaning mechanism and the optical component, thereby improving inspection consistency and reducing the possibility of physical damage [9]. Before implementation, the cleaning process relied on direct operator handling using an air gun, as shown in Figure 11(a), which created a risk of contact between the nozzle and the mirror surface. After implementation, the cleaning process was performed using a push-button controlled airflow system, as shown in Figure 11(b), eliminating direct physical contact and improving cleaning consistency. The comparison of the cleaning process before and after implementation is shown in Figure 13.

Figure 14. Comparison of Implementation (a) before; (b) after

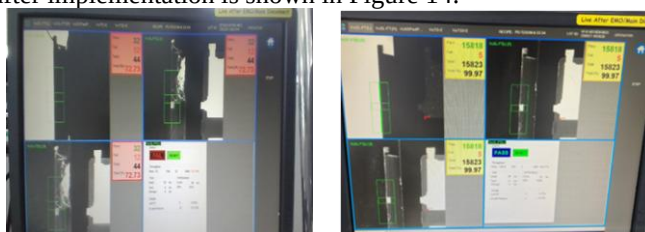
The improvement also affected the quality of the inspection results. Before implementation, the inspection image quality was less stable due to the condition of the Top Mirror Vision, as shown in Figure 12(a). After implementation, the inspection images became clearer and more stable, as shown in Figure 12(b), indicating that the mirror condition was maintained more effectively. The comparison of inspection results before and after implementation is shown in Figure 14.

(a) Before (b) After  
Figure 15. Comparison of Implementation (a) before; (b) after
