Analysis of Flex PCB Failures in Hearing Aid Chargers

Abstract—This research aims to analyze and identify the main cause of the disconnection of the line on the flex PCB which resulted in the LED on the hearing aids charger not working. This problem has an impact on the disruption of the main function of the device and reduces the level of customer confidence in product quality. To understand the root of the problem, this research uses the Fishbone Diagram and Failure Mode and Effect Analysis (FMEA) methods as analytical tools. The research stages include identification of potential causes, failure risk analysis, and improvement planning through the preparation of effective Work Instruction (WI). This research is expected to provide strategic steps in reducing the reject rate in the production process and support the improvement of product quality at PT. XYZ.

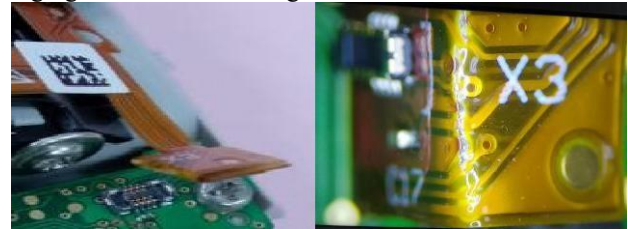
Figure 2. Defect Flex PCB

Based on Table IV, the FMEA analysis shows that the identified failure mode was a PCB flex handling procedure error, resulting in damage to the PCB flex path. The impact of this failure is that the indicator light on the charger does not turn on, even though the main function of charging remains normal. The Severity (S) value is given as 6, because the indicator that does not work can cause confusion for users in ascertaining the charging status of the hearing aid.

A potential cause of this failure is the absence of clear folding instructions in the assembly process, resulting in over-folding or incorrect handling of flex PCBs. The Occurrence (O) level is rated 8, as this problem is found quite frequently during the production process. Meanwhile, the current detection capability (Detection/D) is at a value of 3, Because the damage is usually only known during the final check or after the function test.

From this assessment, a Risk Priority Number (RPN) value of 144 was obtained, which indicates that this mode of failure has a fairly high level of risk and needs immediate action.

Based on Table V, the proposed preventive measures are the preparation of a Work Instruction document that contains technical guidance regarding flex PCB folding, including angle limitations, folding positions, and prohibited areas. The creation of this WI aims to provide clarity and consistency in handling components during the production process.
