Analysis of Grounding Issue in E-House Fabrication

Final Project

**Electronics Manufacturing Engineering Study Program
Electrical Engineering Department
Politeknik Negeri Batam
2025**

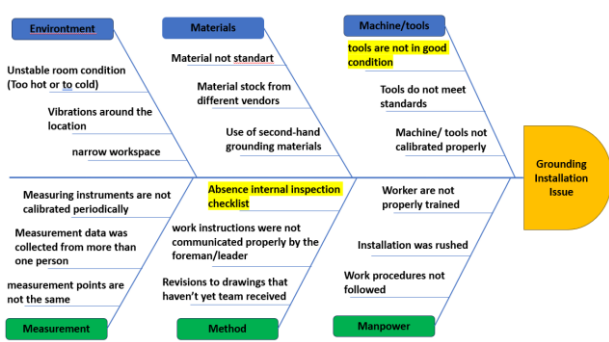
Figure 2. Fishbone Diagram

As shown at Figure 2. Fishbone Diagram, also known as an Ishikawa diagram, which is an analytical tool used to systematically identify and classify the various causes of quality problems. This method is also widely used to map organizational challenges to support tracing the root causes of problems. In this study, the fishbone diagram was used to categorize the primary causal factors and facilitate further analysis using the 5 Whys method to identify the root causes of grounding problems in a more structured method.[6] [7]

Based on the verification results on Table 1, the author concludes that Grounding issue are caused by Two factors, namely Machine/tools factors and method factors.

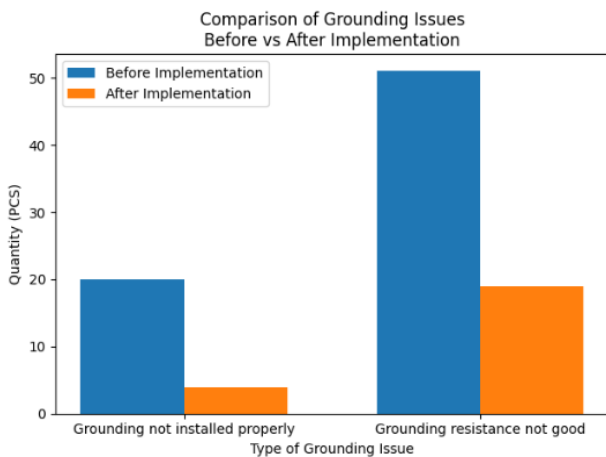
Figure 5. Comparison of grounding issue before vs after

All inspections were carried out using the same criteria by the same personnel with the same equipment so the results could be directly compared. As Figures 3 and 4 show, there was a significant reduction in grounding issues after corrective actions were implemented. Improperly installed grounding and inadequate grounding resistance decreased significantly, indicating improved installation quality and connection reliability. The downward trend across inspection periods confirms that the implemented actions effectively addressed the dominant root causes. Thus, the corrective actions effectively reduced grounding issues and improved the overall quality of the grounding system during the E-

After identifying the root causes, corrective improvements were implemented. A third-party calibration vendor recalibrated the torque tools used for grounding installation to restore measurement accuracy and ensure compliance with applicable standards. These tools were only reused after meeting the required tolerance limits.

Additionally, a post-installation grounding checklist was implemented as a control mechanism. The assigned technician carried out the installation, and then completed a post-installation checklist. A supervisor then verified the checklist to ensure compliance with the design drawings and technical specifications. This verification process served as a control mechanism to confirm that the implemented improvements were properly applied. After implementing corrective improvements, follow-up data was collected during the next grounding installations to evaluate the improvements' effectiveness.
