Analysis Process Of Insulation Test On Buzios P 80 Module

Abstract— The Búzios P-80 FPSO (Floating Production Storage and Offloading) construction project requires a rigorous electrical quality testing process to ensure system reliability, one of which is the insulation test. This study aims to analyze the process of conducting insulation tests on the Búzios P-80 module, as well as evaluating the suitability of its implementation against international standards such as IEC 60364. The method used is direct observation of the test implementation, documentation of measurement results, and analysis of the causes of test results that do not meet the standards. The results showed that most of the process had been carried out according to the procedure, but there were some obstacles such as high humidity and less than optimal grounding that affected the insulation resistance value. The conclusion of this study shows the importance of controlling environmental conditions and maintaining test equipment to ensure the accuracy of test results.

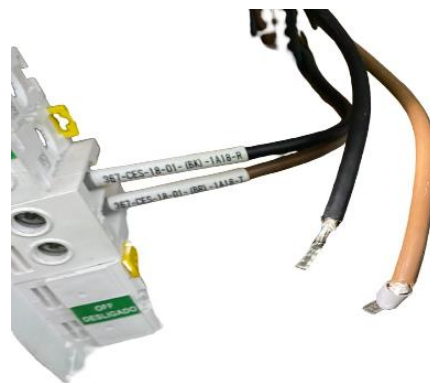
Figure 8. Ferrule Damage

Figure 5. This malfunctioning ferrule was found at the cable termination connected to the terminal. In this condition, it directly contributed to an unstable connection and resulted in low resistance.

The first factor is ferrule damage, which was found at the cable terminal connections. This damage was caused by improper installation and tool damage. These conditions resulted in imperfect electrical contact, increased connection resistance, and increased potential for leakage current, thereby reducing the effectiveness of the system insulation.

For damaged ferrules, the solution is to replace them with new ferrules of the appropriate size and crimp them using standard tools to restore the connection.

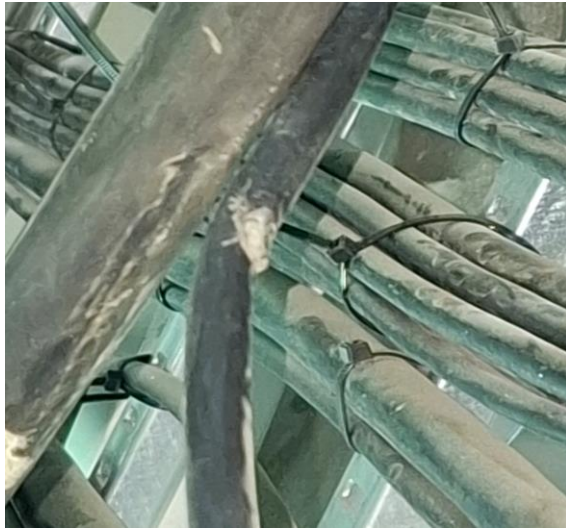
Figure 9. Cable Damage

Figure 6. Identifies significant mechanical damage in the form of tears. These tears have penetrated the protective layer, exposing the conductor core insulation and even the copper conductor inside.

The second factor is cable damage, which occurs due to physical damage to the cable insulation layer. This condition is generally caused by excessive pressure, repeated bending, or scratches from sharp objects. The effects of this condition include cracks, tears, or damage to the cable surface, which significantly reduces the insulation resistance value and increases the occurrence of leakage current.

Cables that have suffered physical damage should be replaced with new cables, especially if the damage is not too severe and can be covered or hesring .

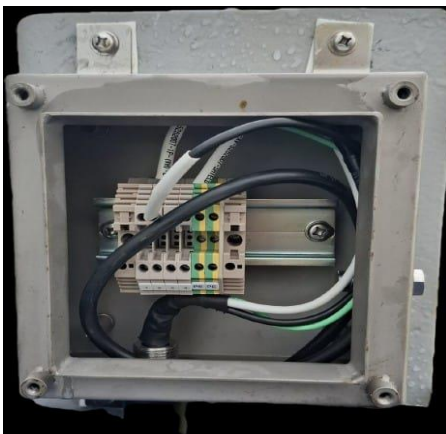
Figure 10. Humidity

Figure 7. Identifying moisture inside the junction box, which affects the cable ferrule and causes low resistance values.

The third factor is humidity or high ambient moisture levels. Testing was conducted in areas with limited air circulation and humid conditions, which triggered the formation of a layer of water on the insulation surface. This layer is conductive and causes the insulation resistance value to decrease. Moisture also accelerates the corrosion process.

If the cable is exposed to moisture, the cable and termination area need to be dried, cleaned, and given additional protection such as heat shrink or insulation. In addition, ensure that the panel and cable route are protected from water ingress.
