# **Analysis of Overheating Combustion Temperature in Stress Relief Furnace Machine**

## **Final Project**

**By:  
Tio Anugrah Iskandar (3222211022)**

**Electronics Manufacturing Engineering Study Program  
Electrical Engineering Department  
Politeknik Negeri Batam  
2025**

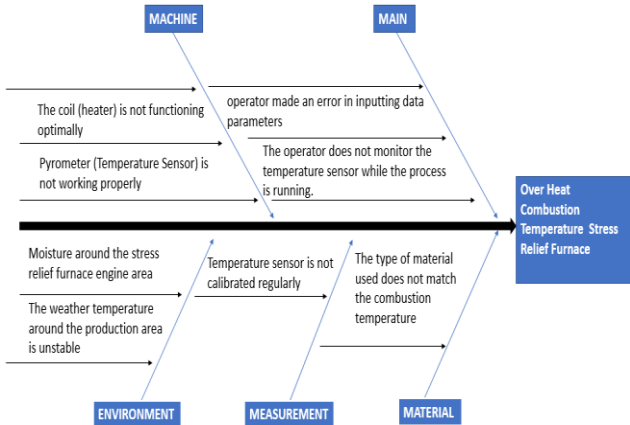
Figure 2. Fishbone Diagram.

The cause of the overheating problem was identified in the Main Engine and Power Supply, based on direct observation and data collection. The fishnet diagram results indicated that operator errors in data parameter input due to a lack of understanding and monitoring of the temperature sensors during the process, as well as inadequate machine maintenance, contributed to the overheating problem.

Based on the verification results, the author concluded that overheating in the Stress Relief Furnace was caused by two potential factors: machine factors and human factors. The following is an explanation of these two potential factors (YES) and an explanation of the potential factors that did not contribute (NO) in Table 2.

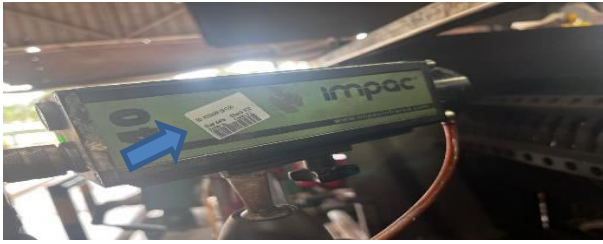
This analysis revealed that the problem was caused by poorly maintained machinery, excessively high surface emissivity values during parameter setting, and suboptimal sensor calibration. Furthermore, the pyrometer sensor had passed its calibration date (data expiration date) according to the maintenance department. The following sensors were overdue for calibration.

Figure 3. Sensor pyrometer not calibrate.

Recommended actions to mitigate the potential causes of this failure include routine pyrometer sensor calibration and preventive maintenance. The parties responsible for implementing these actions are maintenance technicians and company management.

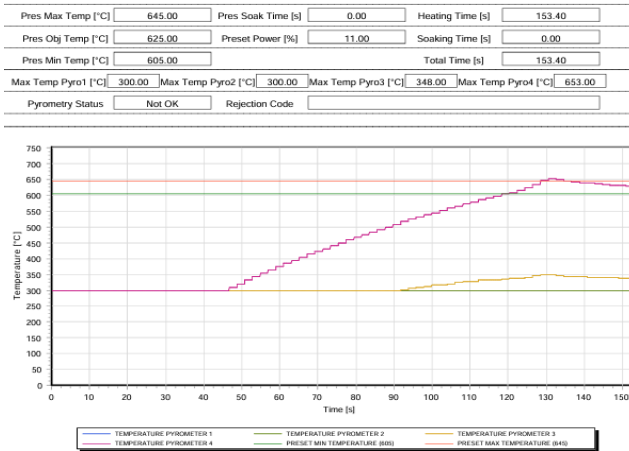
In the pipe heating process of the Stress Relief Furnace, there is a potential for failure due to suboptimal sensor readings. Overheating occurs when the temperature inside the furnace exceeds a predetermined temperature limit. Errors at this stage can cause process instability, serious defects in the quality and durability of the resulting product, and can reduce material strength (yield strength, tensile strength), causing the material to weaken. Distortion causes structural damage to the pipe material, making it susceptible to leaks. It also causes wear on furnace components and reduces operational efficiency, which can be fatal.[14] The following graph shows the results of a 4 1/2" pup joint material with type L80 13CR PSL 3, subjected to overheat, resulting in material rejection.

Figure 5. Display Graphic Overheating Temperature. (Not Good)

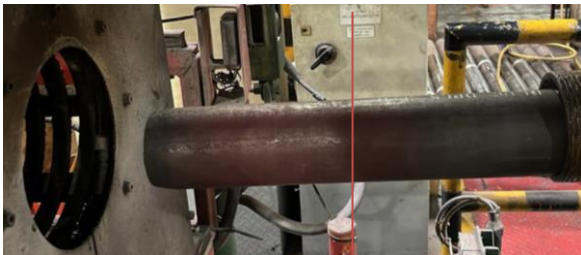
Figure 6. Material Pup Joint overheat combustion (NG)

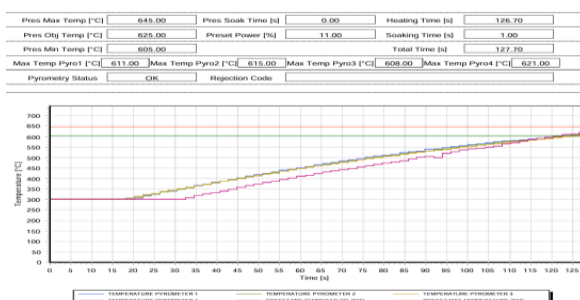
The heating graph remained stable and consistently below the maximum temperature. The heating time was within the required heating time. If all parameters are met, the product is declared OK or Acceptable. The following graph shows the results for 4 1/2" L80 13CR PSL 3 pipe fittings.

Figure 7. Display Graph Heating Temperature (Ok)

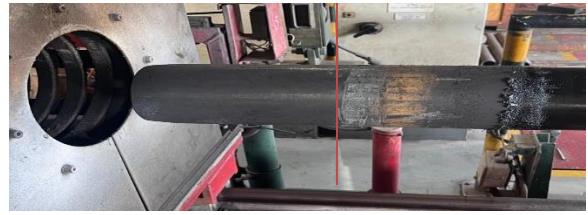
Figure 8. Material Pup Joint after combustion (Ok)

Based on standard procedures, the results of the OK and Reject criteria indicate no visual difference in material impact. The specifications are based on the results of the flaring chart, which uses temperatures within the procedures established by the American Petroleum Institute (API) technical standards.

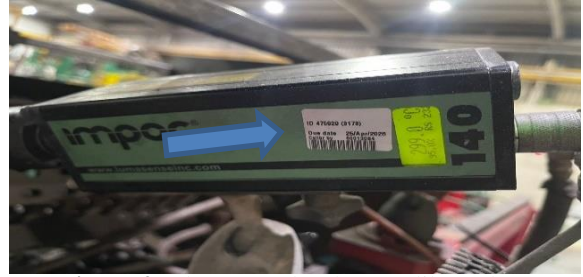
Based on the verification results, the author concluded that, during the first week, the pyrometer remained fairly accurate at low temperatures. The second week remained the same as the previous week, and in the third week, the temperature difference increased, even higher. The following is a checklist for the calibration of the stress relief furnace.

**Figure 9.** The sensor has been calibrated.
