Analysis of PCB Defects in the Reflow Soldering Process Using the PFMEA Method

Final Project

**By:
Tanto Wijaya (3222211001)**

**Electronics Manufacturing Engineering Study Program
Electrical Engineering Department
Politeknik Negeri Batam
2025**

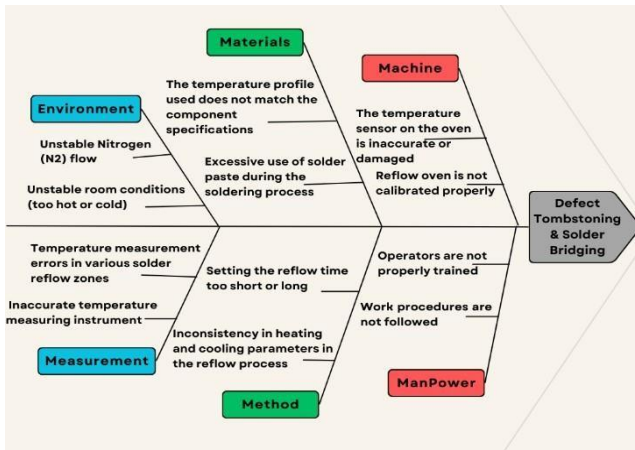
Figure 2. Fishbone Diagram.

In figure 2, A cause-and-effect diagram, Ishikawa diagram, or Fishbone is a diagrammatic analysis tool used to identify the root causes of problems. In a Fishbone diagram, causes are divided into 5 to 6 root cause groups, starting with M [4]. The underlying problem can be placed in the right part of the diagram at the head of the fishbone, while the causes are placed in the fins and spines. The causes of the problem can be measurement, environment, method, material, human, and machine. All causes are kept definite to avoid undesirable, and PCB defects caused by reflow soldering machine.

Based on the verification results, the author concludes that PCBA defects are caused by two potential factors, namely material factors and method factors. The following is an explanation of the two potential factors (YES) and an explanation of the potential factors that did not contribute (NO) in Table 1.

3. Material (YES)

Excessive use of paste solder during the soldering process: Excessive use of solder paste can cause bridging (short circuit between component legs) [8]. The temperature profile used does not match the component specifications; If the profile is appropriate for most of the components or only a few components are not appropriate, then the impact is not significant. Or maybe the profile has been validated before [9].

Based on the analysis, Excessive use of solder paste can potentially cause defects that occur at the joints between two or more pads or pins on SMD PCBs.

4. Method (YES)

Inconsistency in heating and cooling parameters in the reflow process: Inconsistency in heating and cooling can cause the solder to not stick perfectly or cause tombstoning [10], [11], [8]. Setting the reflow time too short or long: As long as the total time is within tolerance and does not cause the soldering to overheat or cool down, then the reflow duration itself may not be the main cause [9].

Based on the analysis, there is a problem in the parameter profile of the reflow process that is not well controlled. Inconsistencies in heating and cooling parameters can lead to incomplete solder melting or unbalanced tensile forces.

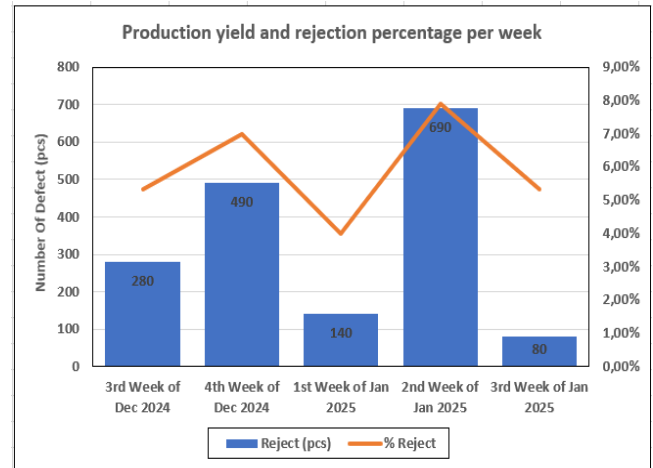
Figure 3. Production yield and rejection percentage per week Before Action.

Based on the Pareto Diagram in Figure 3 before corrective action is taken, it shows the number of rejected product pcs and the percentage of rejects in the production process with a span of five weeks from Week 3rd December 2024 to Week 3rd January 2025. The highest number of rejects occurred in the 2nd week of January 2025 as many as 690 pcs with a percentage of (8.0%), while the lowest occurred in the 3rd week of January 2025 which was 80 pcs with a percentage of (5.6%). The fluctuation in the number and percentage of rejects each week indicates instability in the production process. This needs to be analyzed further to find the root cause and prevent recurring defects.

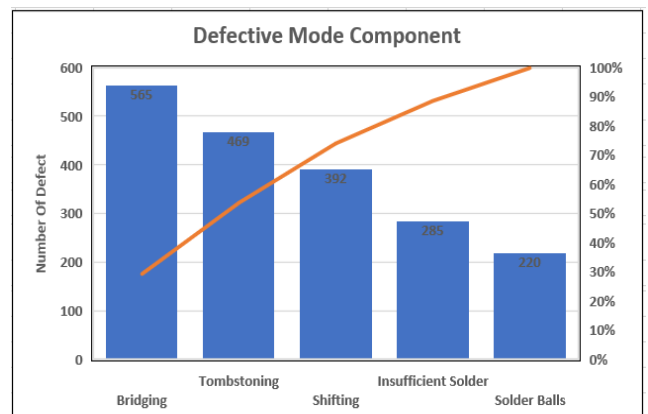
Figure 4. Defective Mode Component Before Action.

Based on the Pareto Diagram in Figure 4 shows the number of defects based on the type or mode of defects in the PCB production process before corrective action is

taken. There are five types of defects, From the diagram it can be seen that Bridging is the most dominant type of defect with a total of 565 pcs, followed by Tombstoning with a total of 469 pcs. The cumulative curve (orange color) shows that the first two defect types (Bridging and Tombstoning) account for more than 80% of the total defects. This indicates that the focus of improvement should be prioritized on these two main defect types, in accordance with the 80/20 Pareto principle which states that most problems (80%) are usually caused by a small percentage of causes (20%).

After the indication of the cause of the PCBA defect is found. To prevent the occurrence of such PCBA defects, the recommended action is to perform stencil calibration on solder paste printing by ensuring accurate solder paste printing and optimizing the stencil design. Prevention by stabilizing the temperature profile of the reflow oven and performing regular calibration of the oven.

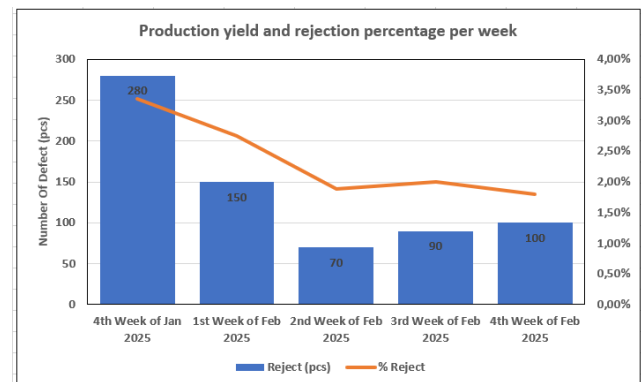
Figure 5. Production yield and rejection percentage per week After Action.

Based on the Pareto Diagram in Figure 5 after corrective action is taken, it shows the number of rejected product pcs and the percentage of rejects in the production process with a span of five weeks from Week 4th January 2025 to Week 4th February 2025. There was a significant decrease in the number of defects from 280 pcs in the 4th week of January 2025 to 70 pcs in the 2nd week of February 2025. The reject percentage also decreased from about 3.6% to 1.7%. Although there were slight fluctuations in the 3rd and 4th weeks of February 2025, the number of defects remained lower than before the improvement. This shows that the corrective actions taken were successful in reducing the defect rate in the production process.

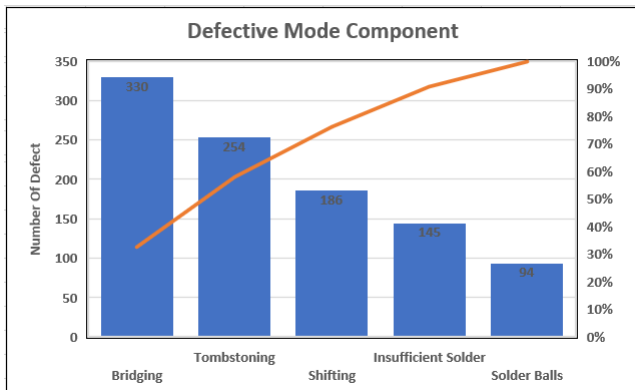
Figure 6. Defective Mode Component After Action.

Based on the Pareto Diagram in Figure 6 shows the number of defects based on the type or mode of defects in the PCB production process after corrective action. Based on the data, the number of defects has decreased significantly compared to the conditions before improvement. The bridging defect is still the highest with 330 pcs, followed by tombstoning with 254 pcs. The cumulative curve shows that the two main types of defects, namely bridging and tombstoning, contribute around 80% of the total defects. This indicates that despite improvements, these two defects remain the main focus for further quality control to reduce the overall number of rejects.

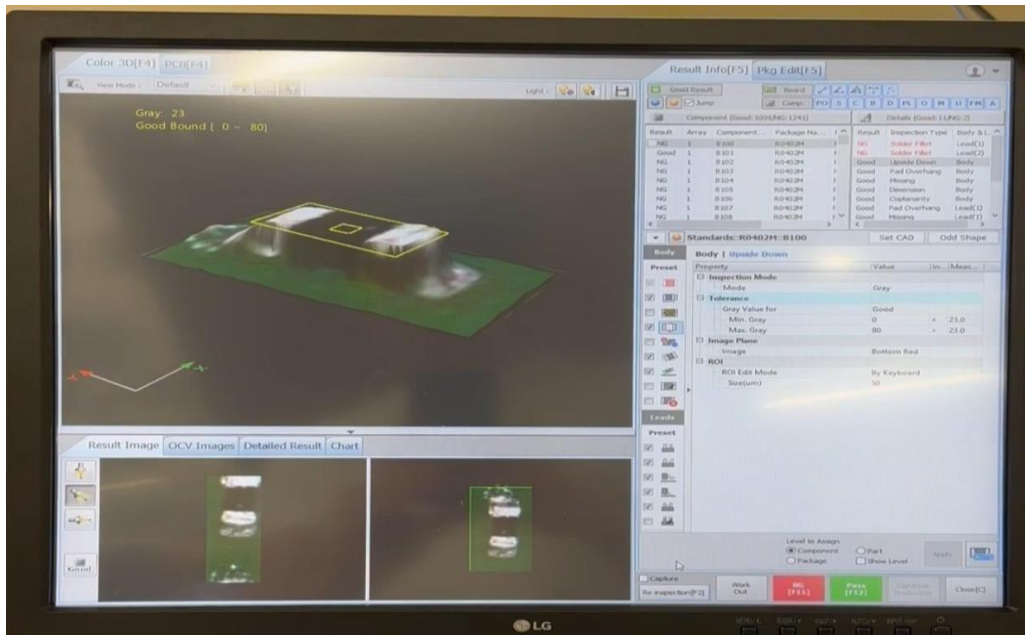
Figure 13. Defective display of SPI machine components

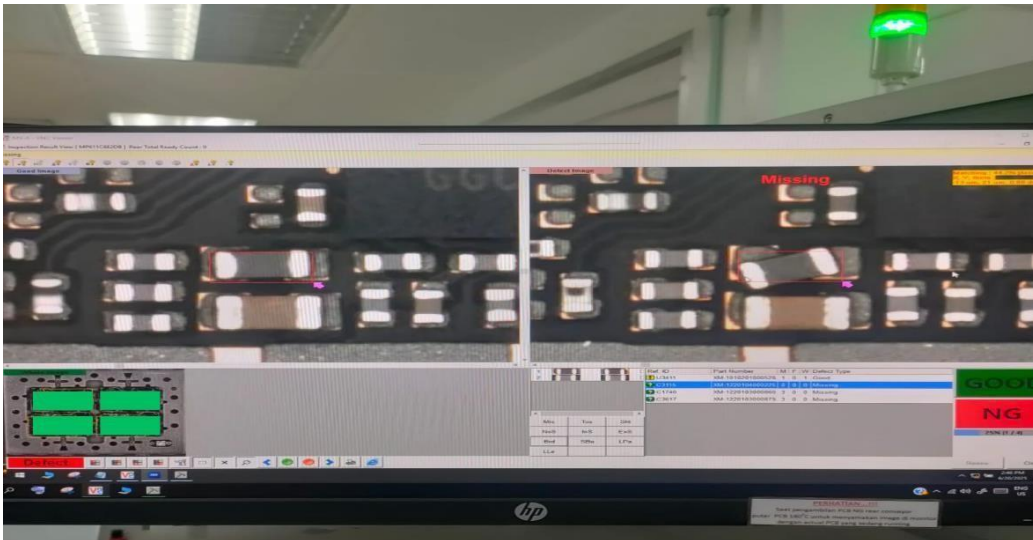
Figure 14. Defective display of SPI machine components

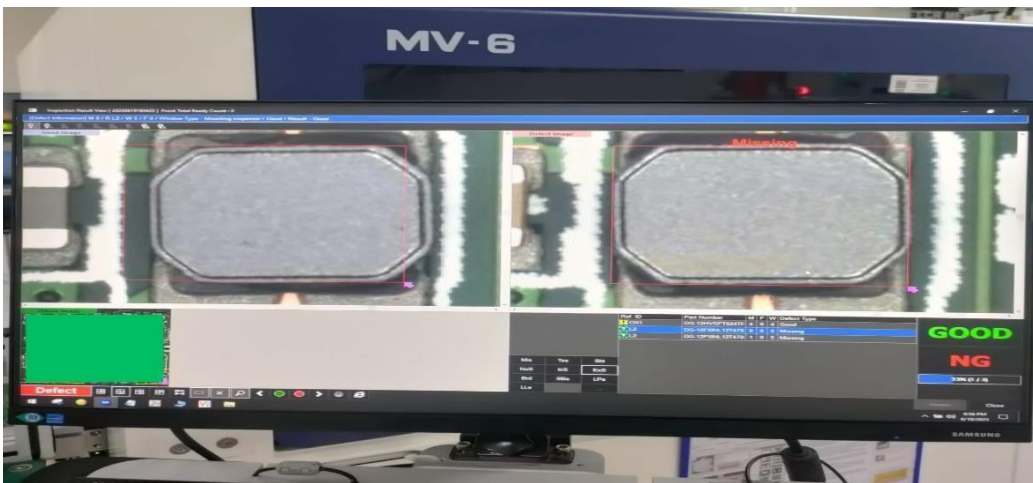
Figure 15. Defective display of SPI machine components

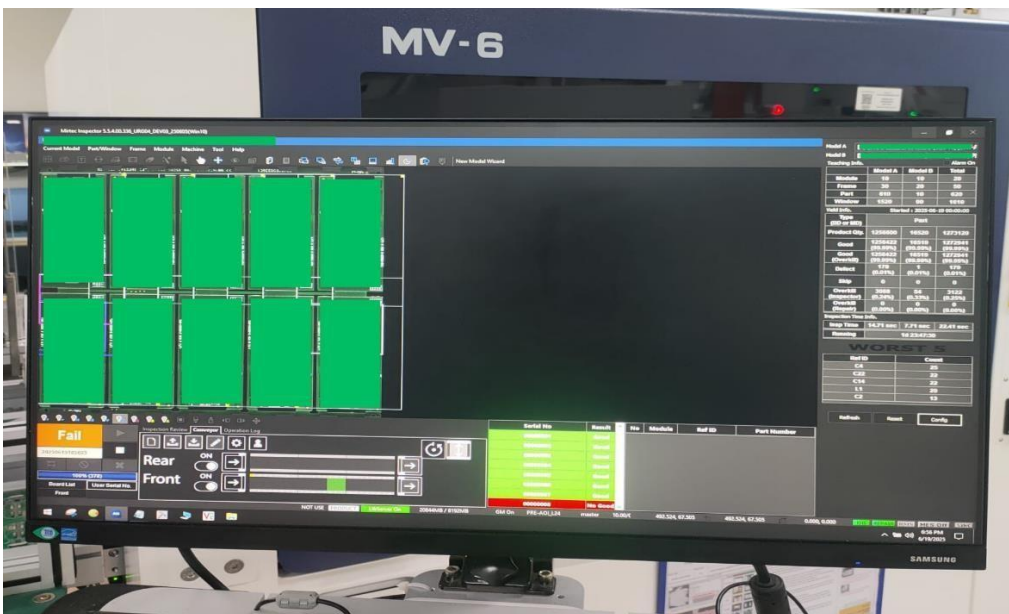
Figure 16. Defective display of SPI machine components
