# **Analysis of Defect in Safety Valves During the Leak Test Inspection Process**

## **Final Project**

**Electronics Manufacturing Engineering Study Program  
Electrical Engineering Department  
Politeknik Negeri Batam  
2026**

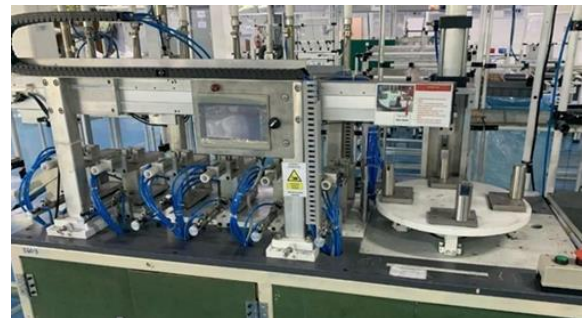
Figure 1. Leak Test Machine

The study began with direct observation of the Leak Test Inspection Process and collection of defect data from the final inspection line. Based on production records, Safety Valve Leak Test Failure was identified as the dominant defect category. To investigate the source of these failures, representative samples were selected for detailed analysis. Each sample was inspected through visual examination, pressure verification, and repeated leak testing. When inconsistencies were identified during product verification, the investigation was extended to the Leak Test Machine to evaluate its operating condition.

The Leak Test Machine operates using pneumatic pressure testing principles, where compressed air is introduced into the Safety Valve and monitored for pressure stability during a predetermined holding period. A pressure reduction exceeding the specified limit indicates potential leakage or other abnormalities. The specifications of the Leak Test Machine used in this study are presented in Table 1

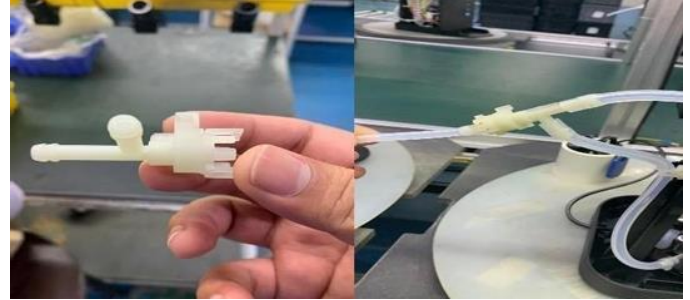
Figure 3 Safety Valve

Each selected sample underwent several inspection stages, including visual inspection of the Safety Valve, pressure

verification using a calibrated pressure gauge, and repeated Leak Test evaluation. The purpose of these inspections was to determine whether the observed failures originated from actual Safety Valve defects or from abnormalities occurring in the Leak Test Machine.

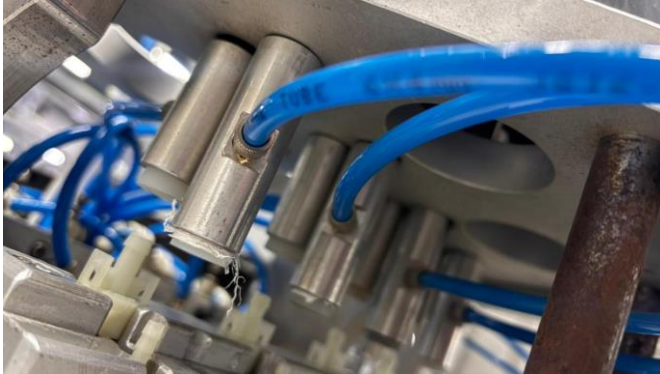
Figure 4 Pressure Verification Setup for Safety Valve Inspection

To investigate the dominant source of failure, 210 new Safety Valve samples were used for a detailed investigation involving visual inspection, pressure verification, and repeated leak testing. Each Safety Valve was first inspected visually to identify abnormalities such as sealing surface damage, spring

deformation, and assembly defects. Pressure verification was then conducted using a calibrated pressure gauge to confirm whether the Safety Valve maintained pressure within the specified operating range.

The investigation showed that most Safety Valve samples satisfied the required specifications and were able to maintain stable pressure during verification testing. Only a small number of samples exhibited actual defects, including minor sealing imperfections that could contribute to leakage.

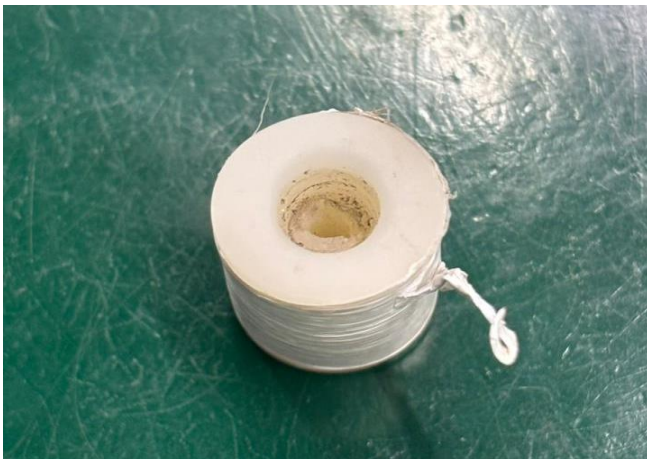
Figure 5 Damaged Pneumatic Tube Identified During Investigation

Visual examination of the Leak Test Machine identified damage in the pneumatic tube used during the pressure holding process.

The damaged pneumatic tube allowed compressed air to escape during testing, causing unstable pressure readings and generating false reject decisions. Consequently, products that

actually met the required specifications were incorrectly classified as failed during the Leak Test Inspection Process.

The investigation confirmed that failures originated from both product-related defects and inspection-equipment-related problems. However, the dominant contributor to the observed failures was leakage in the pneumatic tube, while actual Safety Valve defects were identified in only a limited number of samples.

The damaged pneumatic tube was replaced with a new tube that met the required operational specifications.

The first corrective action involved replacing the damaged pneumatic tube and the worn pneumatic tube connector to eliminate air leakage during the pressure holding stage. This improvement was expected to restore pressure stability and improve the accuracy of the Leak Test Inspection Process.
