# **Comparison of Data Before and After Reverse Engineering on PCB Channel**

## **Final Project Proposal**

**Program Studi Teknik Elektronika Manufaktur  
Jurusan Teknik Elektro  
Politeknik Negeri Batam  
2023**

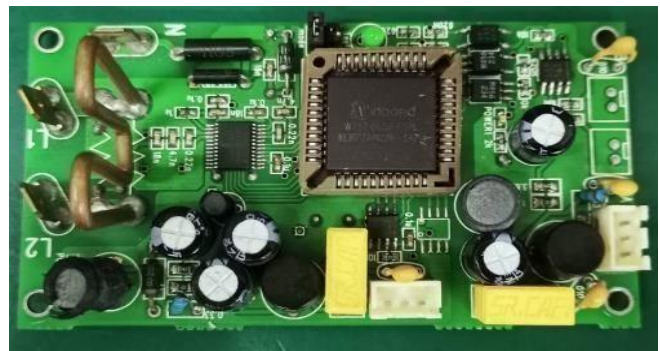
Figure 1. Picture of PCB Channel

PCB Channel serves to convert AC voltage (alternating current) into DC voltage (direct current). In addition, PCB power supply has features such as protection against overvoltage, protection against overcurrent, and voltage division according to application needs. PT Simatelex Manufactory Batam Usually used for product testing machines such as wet-test, BIT (Build in test), and Voltbar monitoring. The voltage issued by the output of the PCB Channel is a maximum of 120V-126V, if the product testing voltage exceeds or is less than the specified number, then the item cannot be tested, because if it is less or exceeds the specified limit it can be considered abnormal on the machine, the solution to reduce abnormal things is monthly machine maintenance.

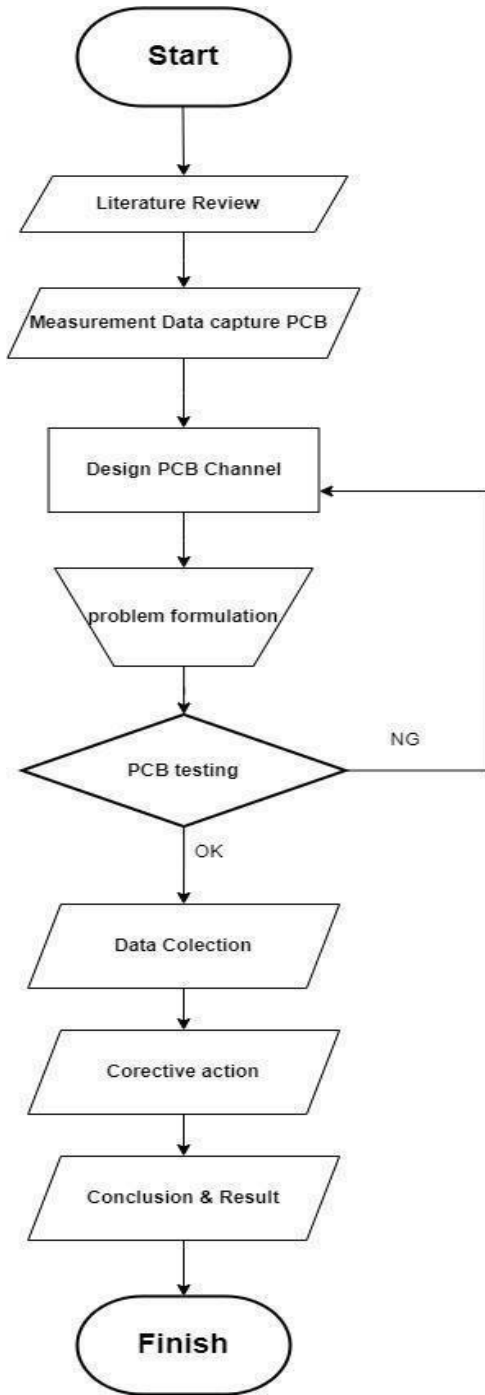
Figure 2. Flowchart

To achieve research results as expected, this research begins with a literature study which includes library data collection activities, reading and recording information related to this research. Followed by Process Disassembly

and Reassembly. After the process, then create a schematic for PCB Channel.

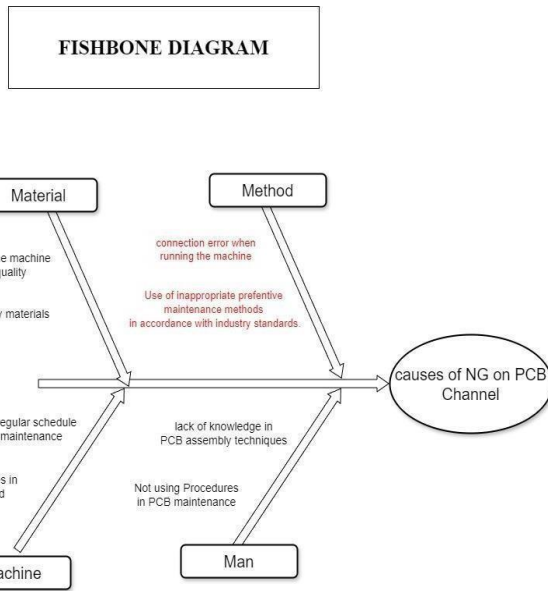
Figure 8. Fishbone Diagram

as seen in the fishbone diagram image, the cause of the problem that is approaching the PCB Channel damage is from the method. because when the PCB Channel is short, the PCB cannot read the voltage given by the 120V travo, but I will explain one by one about my fishbone results.

From the fishbone, the root of the problem is known. errors that often occur are methods, due to the use of improper methods during machine maintenance, machine repair and others. and seen from the actual it is quite often the case that using methods is not in accordance with company standards.

The testing equipment used in this final project is a 120V Multimeter and Travo, to see the volt standard on the PCB Channel and the tool used for data input is a fishbone diagram. The rootcause of the problem in the title is implemented using the fishbone method, as a way to find out which one is close to the root of the problem. the following is a fishbone diagram:

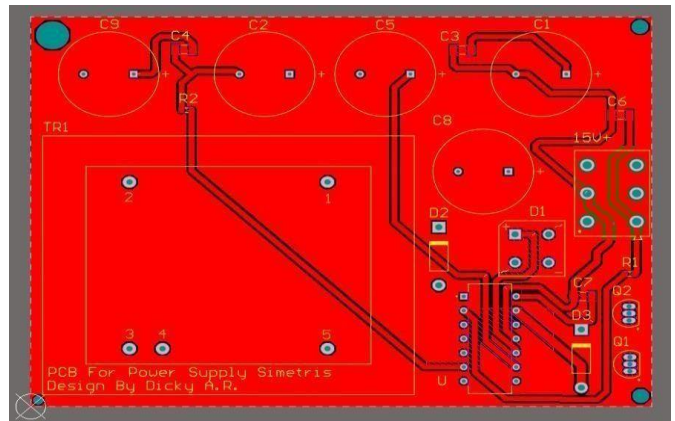
Figure 4. PCB Channel Design Top Layer

From Figure 3 of the Channel PCB schematic, the IC component that I use is LM324N which is used by the Channel PCB. and the design in pictures 4 and 5 was made to the size of the PCB Channel, namely 9.4 mm long and 5.1 mm wide, and for picture 6 because it used a 3D concept to add

illustrations before the PCB Channel was made. for image 4 of the top layer design, image 5 of the bottom layer and image 6 of the 3D design as follows:

for the image above is the result of the design of the top layer for Figure 4, and the bottom layer in Figure 5 and the layer images for Figures 4 and 5 are the result of the schematic

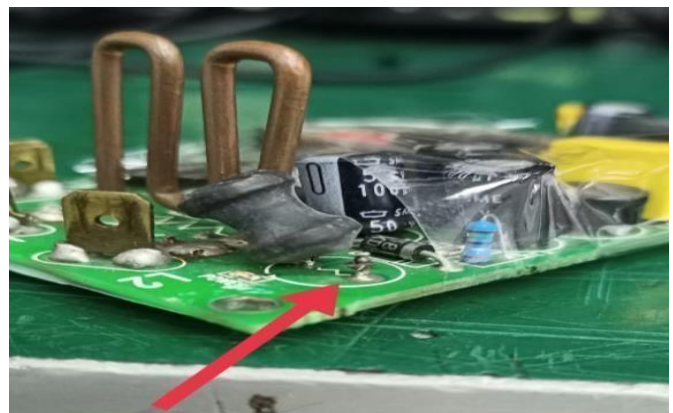
Figure 7. NG impact of connection error causes

As can be seen in Figure 7, the cause is the NG results in Table 3, data after improvement. Connection errors impact the components on the PCB Channel which experience a short on the PCB Channel components. This damage could also be due to the use of low quality materials, but this is a small possibility because before testing the author checked first using a multimeter whether the materials and connections were OK or not, after that the PCB Channel test was carried out in 1 day for 4 PCs.

and it can be said why the PCB channel often experiences damage, because connection errors often occur and also if it is not a connection error, it is possible that the PCB channel experiences a voltage leak and thus experiences a short.
