# **Reducing Shining Surface Defects on Housing Components Through Process Optimization**

## **MBKM Independent Study Final Report**

**Electronics Manufacturing Engineering Study Program  
Electrical Engineering Department  
Politeknik Negeri Batam  
2026**

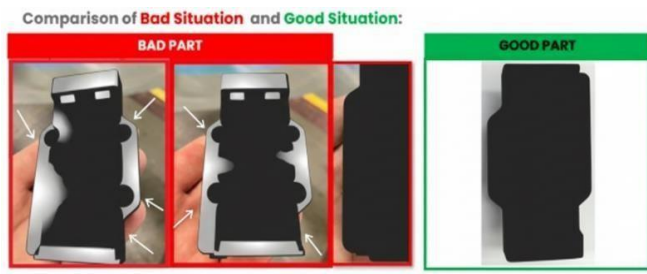
Figure 4. Comparison Bad Part and Good Part.

As illustrated in Figure 4, an acceptable unit exhibits a uniform texture, whereas defective units display a distinct, unacceptable shining surface exactly where the mechanical pressure is applied. The white arrows on the defective part clearly indicate these localized shining areas, which fail to meet the required visual standards. This direct correlation between the jig's contact footprint and the defect locations indicates that evaluating and optimizing the physical interaction between the tooling and the component is necessary to resolve the issue.

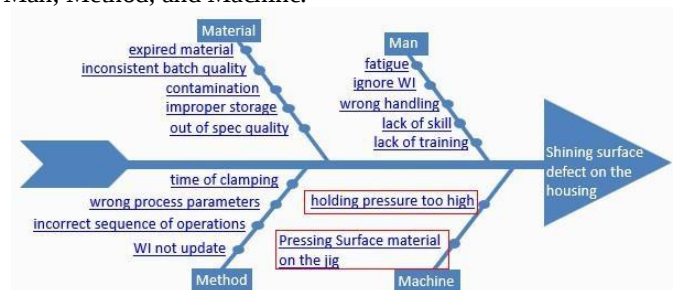
Figure 6. Ishikawa Diagram for Shining Surface Defect Cause Analysis.

Consequently, the investigation successfully isolated two actual root causes (highlighted in red, Figure 6)—namely, "pressing surface material" and the "holding pressure too high"—through the execution of targeted experimental designs. Specifically, the isolation and verification of these two root causes were achieved by conducting a physical trial utilizing 60 component samples to evaluate the impact of the jig's contact surface material, alongside an additional trial of 30 samples dedicated to assessing variations in holding pressure levels. The comparative results from the first trial evaluating the pressing surface material are presented in Table II.
