# Analysis of Technical Anomalies in Power Supply AMR Using FMEA at PT. PLN Batam

**Abstract**— The Automatic Meter Reading (AMR) system plays a crucial role in the efficient collection of electricity consumption data at PT. PLN Batam. However, the reliability of this system is frequently disrupted by recurring damage to the AMR device's power supply, leading to failures in accurate and real-time data transmission. This study aims to identify the primary failure modes, analyze their root causes, and formulate mitigation strategies to enhance the reliability of the AMR power supply. Through a combination of fishbone analysis, Failure Mode and Effect Analysis (FMEA), visual inspection, and component measurements, it was found that the two most significant failure modes are the continuous operation (24 hours) of the power supply and exposure to high ambient temperatures. The FMEA results showed Risk Priority Numbers (RPN) of 175 for frequency of use and 245 for temperature, highlighting the urgency of addressing both factors. Specifically, visual inspection and capacitance measurements confirmed that the 220uF electrolytic capacitor is the most vulnerable component, exhibiting signif

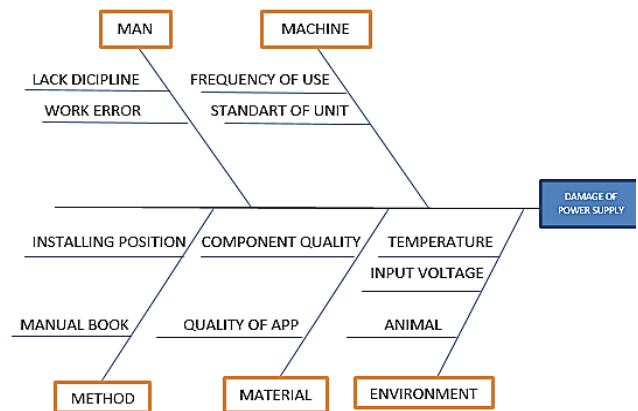
Fig. 2. Fishbone diagram

A fishbone diagram is a visual tool to identify, explore, and graphically depict in detail all the causes associated with a problem. The categories of causes that are often used as a starting point include materials, machines and equipment, manpower, methods, Mother Nature/environment, and measurement [6]. In this problem, Fishbone analysis is used to map potential failure modes that may occur. Mapping is done from various sources of failure, starting from man, method, machine, material and environment which may be the cause of the power supply failure. Figure 2 below shows the fishbone diagram used.

Based on table 6, it can be seen that the 2 (two) potential failure modes identified and considered most relevant are frequency of use (always on 24 hours) and temperature.

This power supply operates continuously for 24 hours a day without ever being turned off. This continuous use raises a strong suspicion that the damage that occurs in the power supply is caused by a high frequency of use factor. The components in the power supply experience constant working pressure, thus potentially accelerating the occurrence of wear and tear of components. Looking at the current control there is also no regulation to rest the performance of the power supply periodically.

In addition to the frequency of use, the temperature factor is also a major concern. This power supply is placed inside the PLN electricity app box. The conditions inside the box tend to have high temperatures, especially when using electricity with high amperage. Plus this device is used for electricity use with

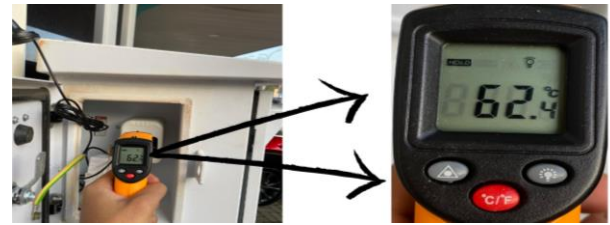
Fig. 3. Measurement Temperature Data Documentation

It can be seen in table 8 that the temperature on the PSU (Power Supply Unit) rises to 62.4 °C when operated inside the APP box. This increase in PSU temperature occurs because the ambient temperature around it tends to be high, influenced by several factors. One reason is that the APP box is exposed to direct sunlight, causing its internal temperature to reach 31 °C. Additionally, other devices within the APP box also emit heat; the digital meter reaches 54.6 °C, the MCCB 48.7 °C, and the busbar 52.7 °C. All these contribute to the PSU's temperature increasing to 62.4 °C, especially during maximum customer current usage.

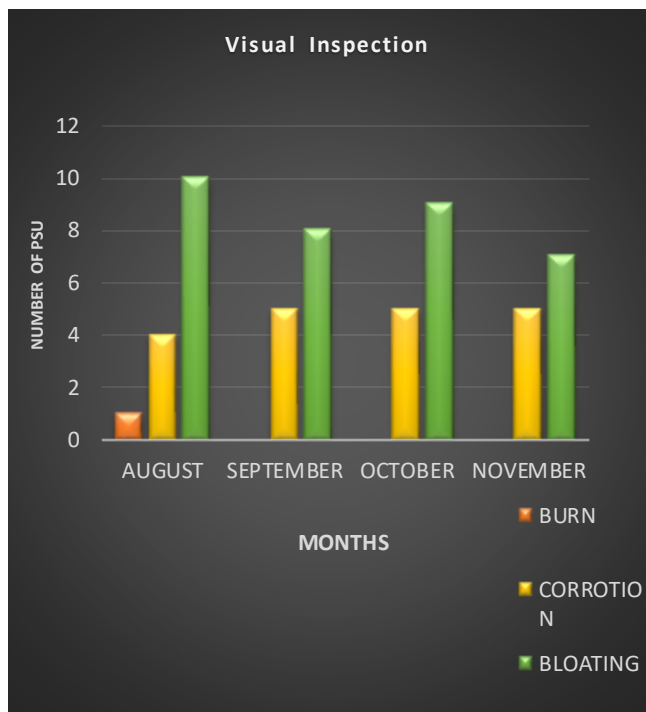
Fig. 4. Visual inspection chart

The graph in figure 4 presents data on the number of visual inspections of defective AMR modem PSUs during the period August to November. These inspections identified three main visual findings: burn, corrosion, and bloating. In August, there was 1 case of burn, 4 cases of corrosion, and 10 cases of bloating. These burnt findings were likely caused by high electrical current surges. In September, October and November, there were no cases of burnt findings. However, corrosion and bulging cases remained dominant. In September, 5 cases of corrosion and 8 cases of bulging were found. In October, 5 corrosion cases and 9 inflation cases were found. In November, 5 corrosion cases and 7 inflation cases were found. Clearly, the corrosion cases were dominated by the feet of the led indicator components and the inflation cases all occurred on the 220 uf electrolytic capacitor.

The graph in figure 4 clearly shows a consistent trend of visual findings, where bulging and corrosion are the most frequent findings. However, these two trends of findings still cannot be confirmed to be the cause of PSU damage, considering that the PSU damage found in the field is that the PSU output voltage always drops shortly before the modem is connected to the network (reaching peak load). These findings will be further validated by measuring the visual inspection findings, to confirm whether the visual inspection findings are really the cause of the PSU output voltage drop. Figure 5

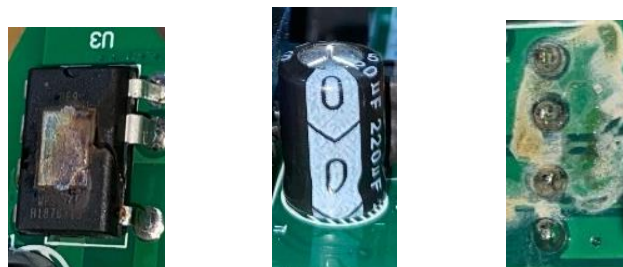
Fig. 5. Documentation of Visual Inspection Result

Visual inspection activities are carried out thoroughly to produce data called visual inspection result data. Some physical conditions of concern are burning, corrosion, and bulging of components. PSUs that have been burned usually have a blackish color in the PCBA area, indicating that the spot has been burned. For corrosion conditions, it is usually indicated by the condition of the pad or lead components that look dirty. The dirt is in the form of rust or others that have the potential to cause a short / bridge between one pad and another

pad, or between one lead component and another lead component. The last is a bulging condition, this is usually experienced by components such as capacitors or ic that have overheated. Capacitors can bulge due to prolonged use without rest, which causes high temperature conditions and subsequently increases the pressure inside them[11]. This inflation is characterized by a change in the condition or physical size of the component from the condition or physical size it should be.

below is documentation of the physical conditions obtained during the visual inspection process.

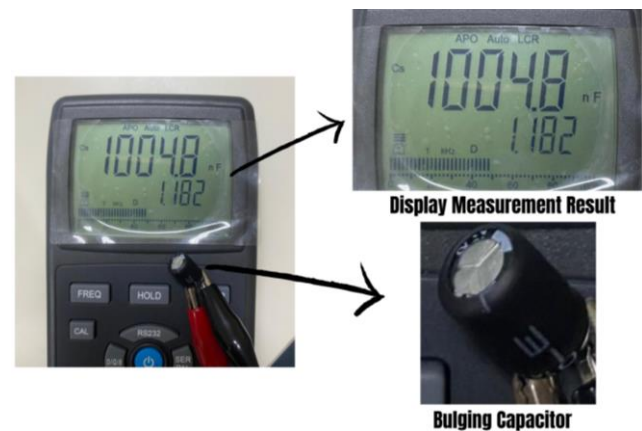
Fig. 6. Component measurement Documentation

However, for the inflation findings on the capacitor, after measurement, a significant deviation in capacitance value was found. The data from the component measurements are presented in Table 10 below.

Based on the component measurement data in Table 10, the component measurement results show a very significant degradation of capacitance in the 220uF electrolytic capacitor that is inflated. This highly significant degradation indicates that the capacitor has experienced severe damage or breakdown. This degradation confirmed the visual inspection findings that identified bulging in the capacitor, and validated that a breakdown had indeed occurred in the component. Figure 6 below are some examples of images documenting when measurements were taken on capacitors that experienced physical bulging and deviation in capacitance values.

Based on the data in table 10, it can be concluded that the percentage of damage to a total of 42 PSUs checked in 4 months is 83.33%. This is because the total defective capacitors of the 42 PSU units inspected were 35 capacitors. The calculation is as follows :

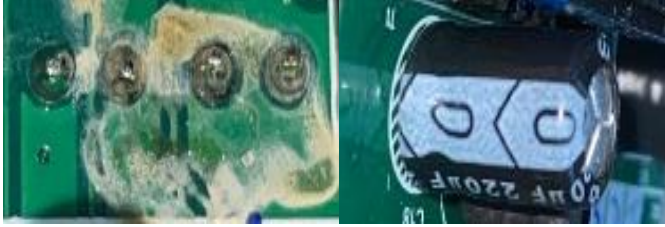
Fig. 7. Defect Component

Visual inspection revealed physical damage to the PSU components, such as corrosion of component bearings and bulging capacitors. The bulging capacitors supported the FMEA findings of component degradation due to high temperature and wear. However, for the corrosion findings, after observation, this occurred because the PCBA was not completely cleaned after the production process, so that a lot of residual flux was still left on the pad. Over a long period of time, this residual flux dries out and causes corrosion. However, based on measurements, none of the corrosion

caused a short between pads. Below shows a documented example of a corroded and bulging component.

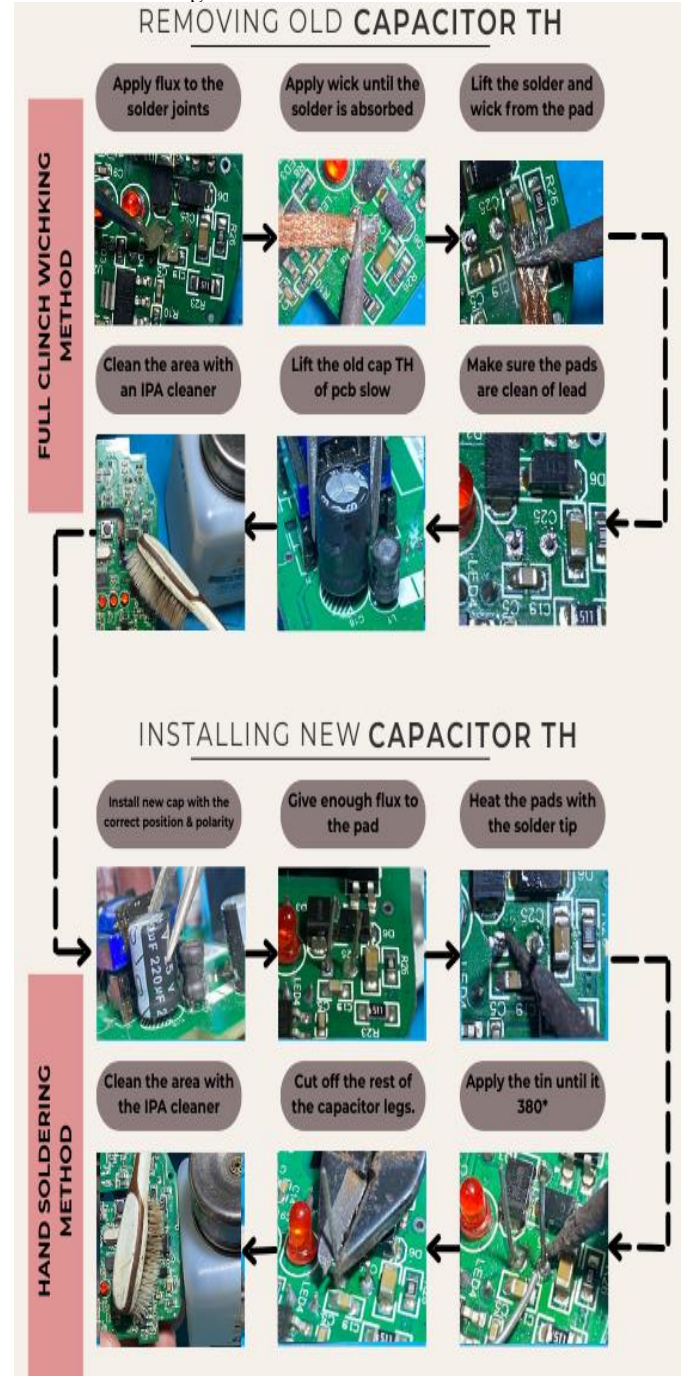
Figure. 8. Rework And Repair SOP

Based on the results of the in-depth analysis and validation, and considering that the initial countermeasure recommendations could not be implemented immediately, the PCBA Rework repair method was recommended as the primary solution to repair the damaged Power Supply Unit (PSU). This method is considered to be much more targeted and significantly easier to implement compared to the initial countermeasure option which may require further customization or greater resources. In a nutshell, PCBA Rework is a precision repair process performed on Printed Circuit Board Assembly (PCBA). The process specifically involves the replacement or repair of individual components that are identified as defective or not conforming to the set specification standards. In the context of this PSU repair, the

main focus of the rework process was to replace defective capacitor components. The decision to choose this PCBA Rework method was based on substantial efficiency considerations. When compared to replacing the entire PSU unit, the PCBA rework approach offered much greater cost savings. This is mainly because this remedial action would only involve replacing a single capacitor component on each faulty PSU instead of the entire unit. This approach not only minimizes material wastage but also reduces operational downtime that may result from procuring and replacing an entire new unit. To ensure the rework process runs according to standards and results in an optimal repair, a PCBA Rework Standard Operating Procedure (SOP) has been developed and can be seen in Figure 8.

Based on the research findings, it is recommended to perform PCBA rework on the damaged AMR PSU, focusing on replacing the 220uF electrolytic capacitor based on the PCBA rework SOP that has been given. This can restore the performance of the PSU as before. With this recommended repair action, it is hoped that it can restore the reliability of the damaged PSU, and replace the solution of replacing a new PSU with a much lower cost.
