# **Analysis of The Effect of Machine Painting on The Number of Machines Certified as Green Line at Testing Area**

## **Final Project Proposal**

**Electronics Manufacturing Engineering Study Program  
Electrical Engineering Department  
Politeknik Negeri Batam  
2023**

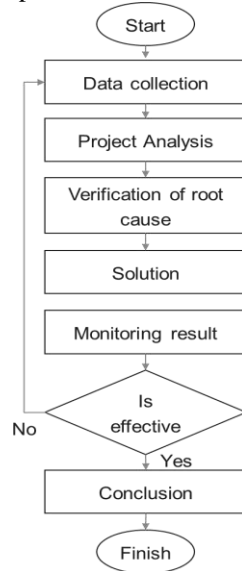
Figure 1. **Flowchart**

branches, and actual outputs of a process. [5]. The use of flowcharts makes it easier when conducting checks related to problem analysis [6]. The following are the steps to certify the machine and perform repairs on the machine.

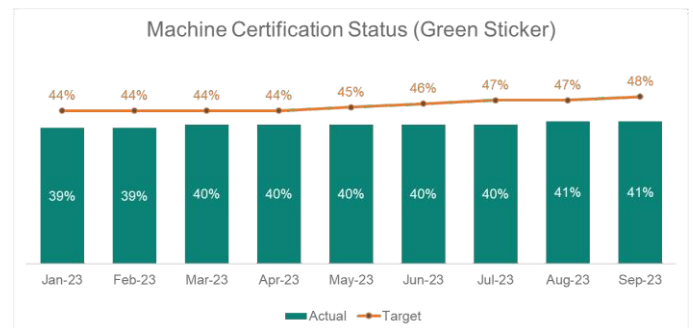
Figure 2. **Green Status**

From the analysis of visual data extracted from the database, it can be seen that the achievement of Green Line machine certification for green stickers during January - September 2023 is not consistent in achieving the set targets. A machine certification target of 90% for all Infineon back ends (Asia Pacific) was decided at the Greenline Cluster Workshop. In Infineon Batam, the machine certification target is 2 for assembly and 35% for test, with an overall target of 55%.

This is the underlying issue that prompted the implementation of the project. As time passes, the set targets will continue to increase, for example, by the end of May 2024, the target for green line machine certification is set at 64%. If the issue is not resolved promptly, the gap between actual performance and the target will widen. This will lead to poor performance of Infineon Batam in the eyes of the management and other external Infineon entities.

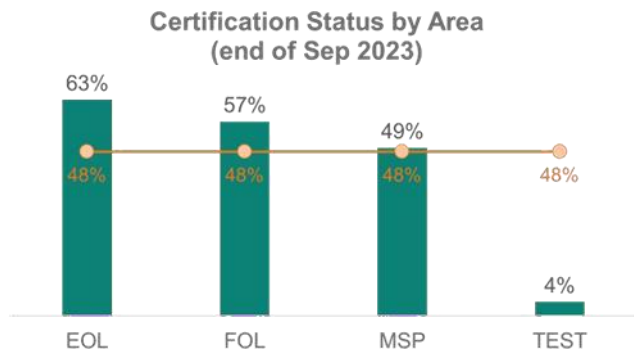
Figure 3. Certification Status Test Area

The breakdown of machine certification by area indicates that the Test Area has the lowest achievement at 4% compared to the other areas. Meanwhile, the other three areas, namely EOL, FOL, and MSP, have higher achievements, even exceeding the set target of 48% in September 2023. Therefore, the focus area for project implementation is determined to be the Test Area. If the certification achievement in the Test Area can be high, it is expected that the overall achievement of Green Line machine certification in Infineon Batam can reach the target.

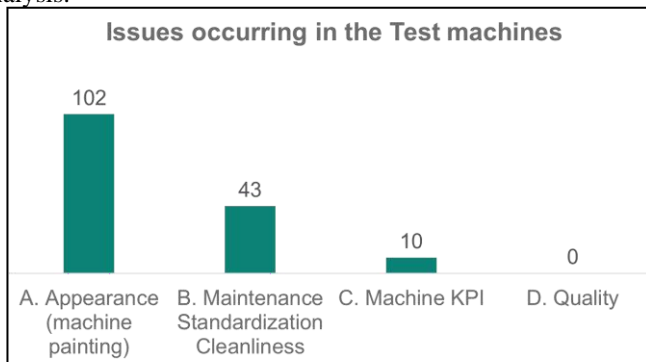
Figure 4. Issues Occurring In The Test

From the above bar chart, we can see that the most prevalent issue found in the Test area is the condition of the machines not meeting the criteria specified in item A of the Green Line machine certification checklist, which is Appearance (machine painting).

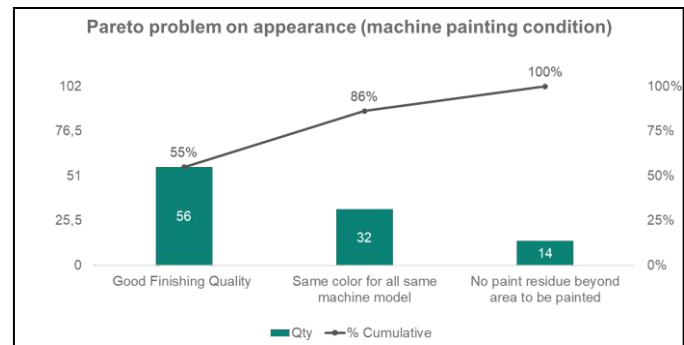
Figure 5 .Pareto chart

From the Pareto chart, it can be observed that the condition of machines not meeting the criteria for Good Finishing Quality and Same color for all same machine model contributes the most significant issues, with frequencies of 56 and 32, respectively. These two factors contribute to a total contribution of 86%. Therefore, further analysis will be focused on these two issues.

For a deeper problem analysis, the next step involves using a Pareto chart to identify the most significant factors contributing to machines not meeting the criteria specified in item A of the Green Line machine certification checklist, which is Appearance (machine painting). This approach is based on the Pareto principle, also known as the 80/20 rule, which suggests that roughly 80% of the effects come from 20% of the causes.

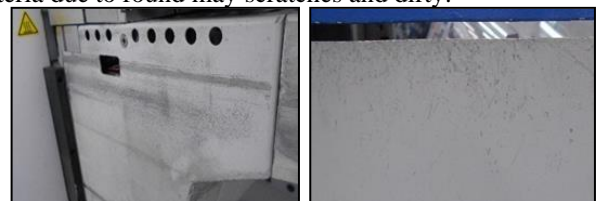
Current painting condition is not meet the certification criteria due to found may scratches and dirty.

Figure 6. Dirty and scratches found on machine cover

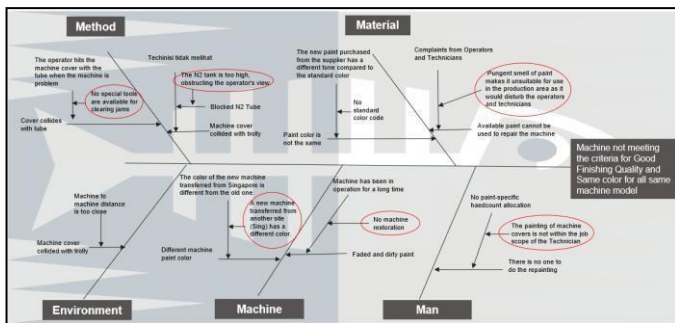
Figure 8. Fishbone Diagram

From the above fishbone diagram, we can see that there are 8 potential causes originating from 4M1E (Man, Machine, Material, Method, and Environment), which will undergo further verification.

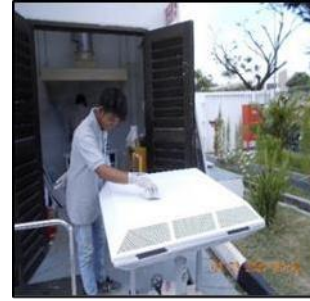
Figure 9. **New Type of Painting (Odorless)**

In the figure above, it can be seen when the machine user takes corrective action on the machine cover, namely by removing the damaged machine cover and then taking it out of the production area and then taking corrective action by applying paint to the machine cover. And it should also be noted that the paint used on the engine cover prioritizes paint that does not smell strong like odorless paint.

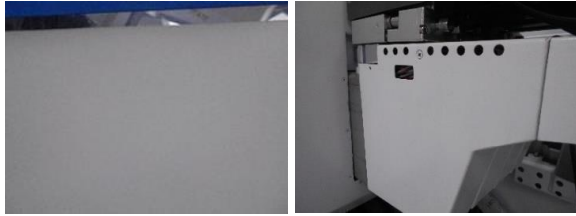
Figure 11. After Painting

- The paint condition on the machine cover meets the certification criteria, with good paint quality, no dirt or scratches.
- Same color across all machines with the same platform.

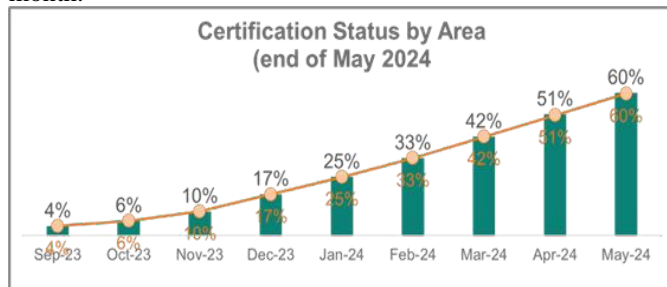
Figure 12. Machine painting Status from Test Area

As depicted in the chart above, the Test area has successfully attained the target machine certification status. This demonstrates the effectiveness of all implemented corrective measures, attributable to thorough analysis and the selection of suitable solutions.
