Failure Analysis of Econo Dual Module Frame Installation in The Automatic Frame Assembly Process

FINAL PROJECT PROPOSAL

**Electronics Manufacturing Engineering Study Program
Department of Electrical Engineering
Batam State Polytechnic
2023**

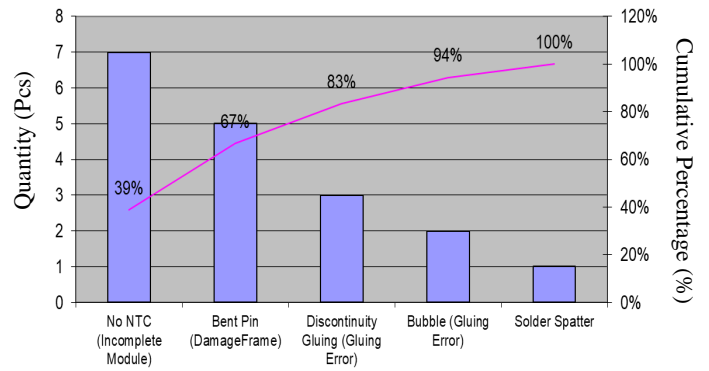
Figure 11. Pareto Chart of Causes of Frame Installation Failure

The above data is one of the data samples obtained by the author which was conducted in a short period. The data was obtained from a temporary experiment at the beginning of the research, which aimed to obtain a hypothesis regarding the main cause of the failure of the installation on the frame. So based on the pareto chart above, the author found that the highest total error obtained was that the NTC was not installed on the module. So for the time being, it can be concluded that the problem that must be resolved first is to focus on checking first whether there is an NTC in the module or not before running it on the machine, so that the process carried out can save time and increase the quantity of products produced.

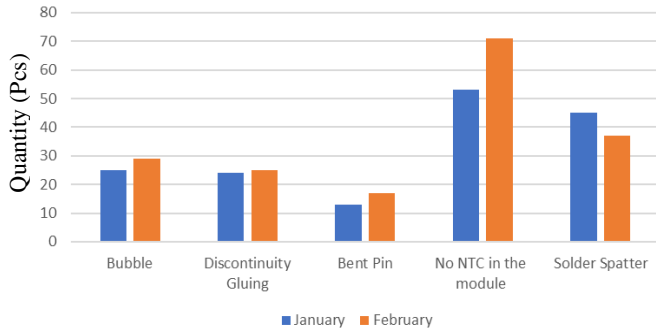
Figure 16. Diagram of research data results before corrective action

From the table and diagram above, it shows that the main cause of the problem is no NTC in the module. This shows that the data results obtained are the same as the data results obtained by researchers in a short period as previously explained in Figure 11, that both show that “there is no NTC in the module” is truly the main cause of the problem that occurred. Before taking corrective action to resolve this problem, it is necessary to first conduct an in-depth analysis of the temporary data results to determine how bad the level of the problem is. The following is the analysis.

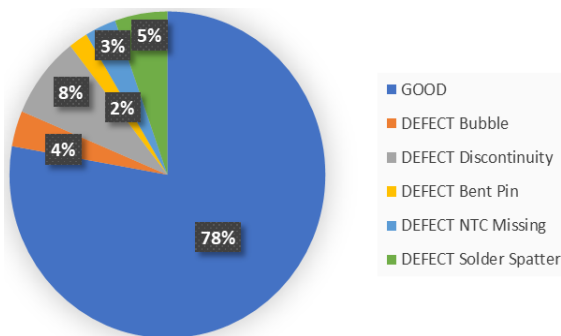
Figure 17. Pie Chart Result Data Before Corrective Action

The 22,2% results obtained were the total defects that occurred and 78% were products that fulfill the specified product specification standards. It can be said that this production process has been running quite well because the total good products are much more than the total defects. But has this production process fulfill the company's standards? And to determine whether this production process can be said to fulfill company standards or not, the author uses the DPMO formula and Six Sigma table as references which have been explained in the Figure 13. And the following is the explanation.

If we look at the Six Sigma reference in Table 1, the data results are still in the range of 2-Sigma level and not reached at 3-Sigma level, which is exceed more than 66.800 units DPMO. Where this level does not include the industry average standard. This means that the production process before taking some corrective actions, not fulfill the company's production standard targets.

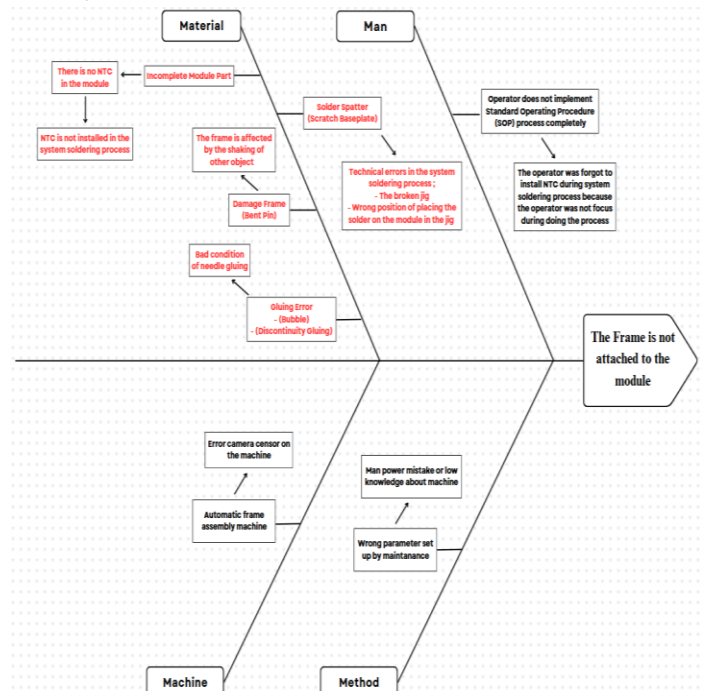
Figure 18. Fishbone Diagram of frame installation failure on module

The red mark in the image above is the cause of the problem of frame installation failure which quite often happened. Most of the causes of failure of frame installation on the module come from material factors. This indicates that material factors are very crucial factors during the frame assembly process. Based on the fishbone diagram above, the root cause of some problem is found. But to find out more deeply about the root cause of this problem, using five whys analysis is one of the best solutions. The 5 Whys tool provided an easy to understand, easy to implement, and therefore less time-consuming tool for determining root cause, which no doubt contributed to the resulting popularity across business sectors [14]. Since the root cause of the problem is no NTC in the module, the focus of the explanation of the five whys is directed at the root cause of “why there is no NTC in the module”. The following is a display of the five whys diagram based on the explanation of fishbone diagram.

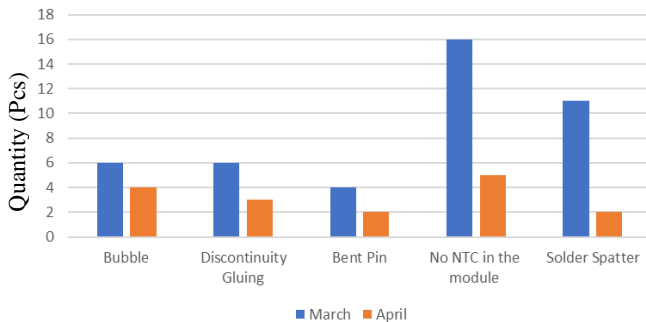
Figure 21. Diagram of research data results after corrective action

After taking corrective action for 2 months, there was a decrease in defects and an increase in production quantity occur. The data results obtained are also different from those before corrective action. The following are the data results obtained:
