# **Identification and Prioritization of Component Failure Risks in the Electrical System at the As Salam Mosque Using the FMEA Approach**

## **Final Project**

**Electronics Manufacturing Engineering Study Program  
Electrical Engineering Department  
Politeknik Negeri Batam  
2026**

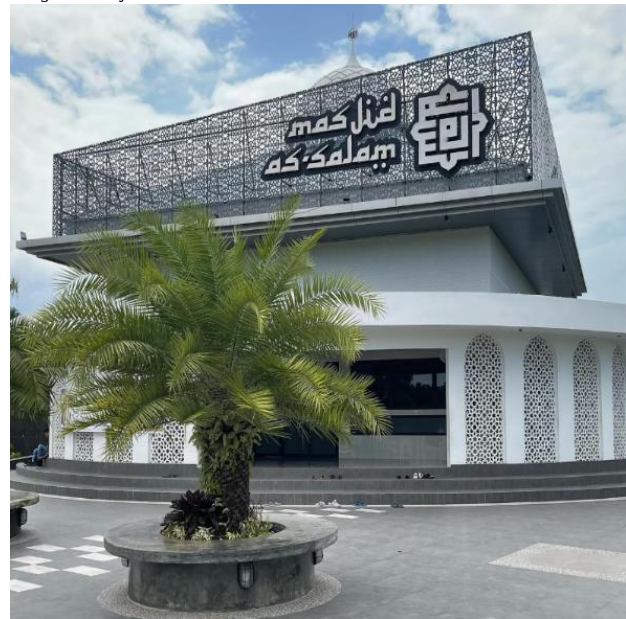
Figure 2. Object location

Figure 2 shows the research object, namely the As Salam Mosque and its lighting system installed in several locations, including the roof near the mosque dome, toilet area, terrace, and garden and parking area. Each location has different environmental and operating conditions, such as weather exposure, humidity, limited accessibility, and installation area coverage. These conditions may affect inspection, maintenance activities, and the reliability of the lighting system. Therefore, a risk analysis is required to identify potential failures at each installation location.
