# ANALYSIS OF TOP MIRROR VISION BROKEN IN TSP (TEST SCAN PACK) MACHINE

Alif Restu Dwi Putra<sup>1</sup>, Vivin Octowinandi, S.Tr.T., M.Sc.<sup>1</sup>

<sup>1</sup>Jurusan Teknik Elektro, Prodi Teknik Elektronika Manufaktur, Politeknik Negeri Batam, Batam, Indonesia

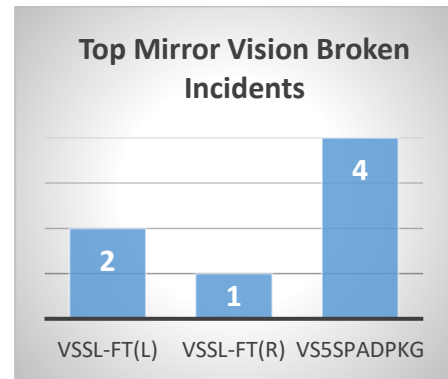
Figure 5. Data Before Top Mirror Vision Broken

Based on initial observation data, the number of Top Mirror Vision broken incidents was recorded across several inspection cameras within a single SRM machine used in the Test Scan Pack (TSP) process. One SRM machine consists of multiple inspection cameras, each utilizing a Top Mirror Vision component. The data shows that damage incidents occurred repeatedly on different cameras, indicating that the problem was not isolated but systematic in nature. Specifically, the highest number of incidents occurred in the VSSSPADPKG camera with 4 cases, followed by VSSL-FT(L) with 2 cases, and VSSL-FT(R) with 1 case. This distribution indicates that the issue affects multiple inspection points within the system. This condition represents the initial state of the system before root cause analysis and corrective actions were implemented, as shown in Figure 5. The detailed monitoring results of Top Mirror Vision broken incidents before implementation are presented in Table I.
