Analysis of Flex PCB Failures in Hearing Aid Chargers

Abstract—This research aims to analyze and identify the main cause of the disconnection of the line on the flex PCB which resulted in the LED on the hearing aids charger not working. This problem has an impact on the disruption of the main function of the device and reduces the level of customer confidence in product quality. To understand the root of the problem, this research uses the Fishbone Diagram and Failure Mode and Effect Analysis (FMEA) methods as analytical tools. The research stages include identification of potential causes, failure risk analysis, and improvement planning through the preparation of effective Work Instruction (WI). This research is expected to provide strategic steps in reducing the reject rate in the production process and support the improvement of product quality at PT. XYZ.

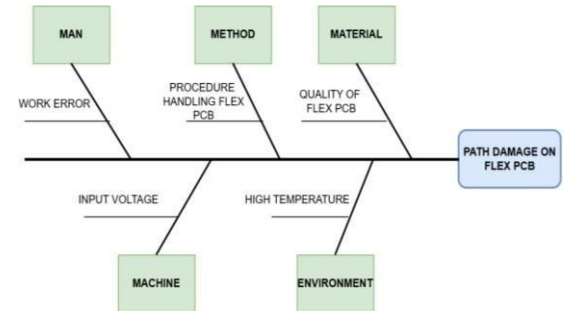
Figure 1. Fishbone Diagram.

Fishbone diagrams are used to identify the root cause of a risk (as shown in Figure 1), thus allowing prediction of potential path failure in flex PCBs and allowing for preventive action to be taken before such risks occur. This diagram illustrates the various factors that contribute to flex PCB damage, by identifying the potential causes of various aspects in the production process. Influencing factors include human, machine, method, material, and environmental aspects, which are described as follows:

The main machine of PCBA (Printed Circuit Board Assembly) as the core of the hearing aid charger assembly process has a high potential to experience technical problems. The source of the problem can come from a malfunction or damage to the PCBA machine itself.

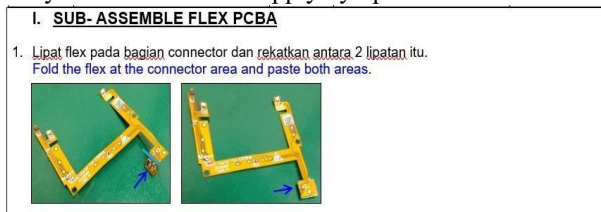
Figure 3. Work Instruction Flex PCBA Before Update

Based on Table III, it can be seen that the most relevant and focus potential failure mode is the PCB flex handling procedure, as identified through fishbone analysis. This problem arises due to the lack of instructions that regulate the folding of flex PCBs in the work instruction (WI) that is currently used. Therefore, the next analysis is carried out using the Failure Mode and Effect Analysis (FMEA) method to evaluate the severity, frequency of events, and detection capabilities of the failure mode, so that appropriate corrective actions can be determined.

The FMEA analysis identified one major potential failure mode that contributed to PCB flex path damage, based on the findings of the fishbone analysis, namely the flex PCB handling procedure. This failure mode was chosen because there is no instructions that regulates the PCB flex folding angle in the current work instruction document.

This Work Instruction is prepared as part of a repair recommendation based on the results of the failure analysis of the Flex PCB in the hearing aid charger. The purpose of this WI is to provide standardized work guidance to minimize the potential failures that have been identified, especially in the installation and handling process of Flex PCB. The preparation

of the WI refers to the findings of the FMEA and is designed to be easy to understand and apply by operators in the field.

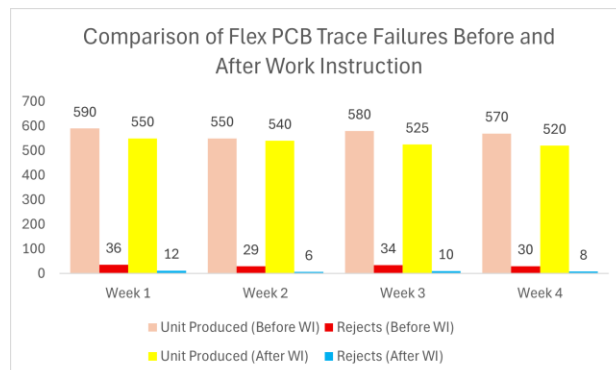
Figure 5. Comparison Diagram of the Number of Reject Flex PCBs Before and After Application of Work Instruction

The results of data analysis show that there has been a decrease in the number of products that have experienced rejection by 72.09% after the implementation of the updated Work Instruction (WI). This significant decrease gives a strong indication that there is a real improvement in the quality of the production process, especially in the installation and handling stages of Flex PCB in hearing aid chargers. The WI improvements made include adding procedure details, completing work steps, and emphasizing the aspect of caution when folding the Flex PCB line, which was previously one of the main sources of failure.
