Analysis Process Of Insulation Test On Buzios P 80 Module

Abstract— The Búzios P-80 FPSO (Floating Production Storage and Offloading) construction project requires a rigorous electrical quality testing process to ensure system reliability, one of which is the insulation test. This study aims to analyze the process of conducting insulation tests on the Búzios P-80 module, as well as evaluating the suitability of its implementation against international standards such as IEC 60364. The method used is direct observation of the test implementation, documentation of measurement results, and analysis of the causes of test results that do not meet the standards. The results showed that most of the process had been carried out according to the procedure, but there were some obstacles such as high humidity and less than optimal grounding that affected the insulation resistance value. The conclusion of this study shows the importance of controlling environmental conditions and maintaining test equipment to ensure the accuracy of test results.

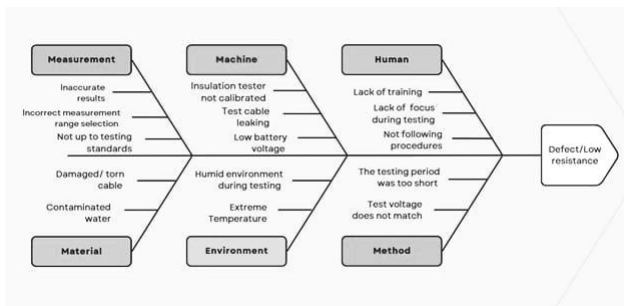
Figure 4. Fishbone Method

Figure 3. illustrates the Fishbone method applied to analyze the root causes of defects or low insulation resistance, focusing on factors related to measurement, machine, human, material, environment, and method.

- **Human**
 - Lack of training:** The operator does not fully understand the insulation testing procedure.
 - Lack of focus during testing:** Reduced attention can affect data validity, especially when procedures are not carefully followed according to operational standards.
