# **Analysis of Overheating Combustion Temperature in Stress Relief Furnace Machine**

## **Final Project**

**By:  
Tio Anugrah Iskandar (3222211022)**

**Electronics Manufacturing Engineering Study Program  
Electrical Engineering Department  
Politeknik Negeri Batam  
2025**

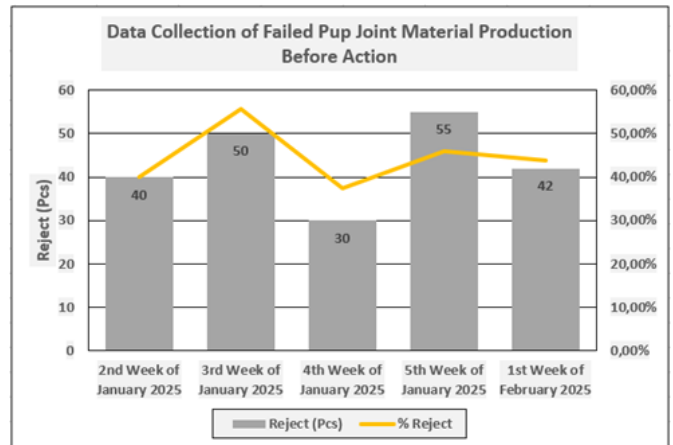
Figure 12. Production reject percentage per week Before Action.

Based on the data in Table 6 above collected before the corrective action was taken, the number of defective pup joint pipe products was recorded for five weeks, starting from the 1st week of January 2025 to the 5th week of January 2025. The data shows that the rejection rate varies each week, with the highest percentage occurring in the 3rd week of January 2025 at 55.56% and the lowest in the 4th week of January 2025 at 37.50%. Overall, the average rejection rate before the corrective action was 44.65%. This high rejection percentage indicates instability in the production process that needs to be immediately identified and corrected to meet the expected quality standards [15].

Based on the Pareto Diagram in Figure 12 before corrective action is taken, it shows the number of rejected product pieces and the percentage of rejects in the production process with a period of five weeks from the 1st week of January 2025 to the 5th week of January 2025. The highest number of rejects occurred in the 5th week of January 2025 as many as 55 pieces with a percentage (45.83%), while the lowest occurred in the 4th week of January 2025 as many as 30 pieces with a percentage (37.5%).

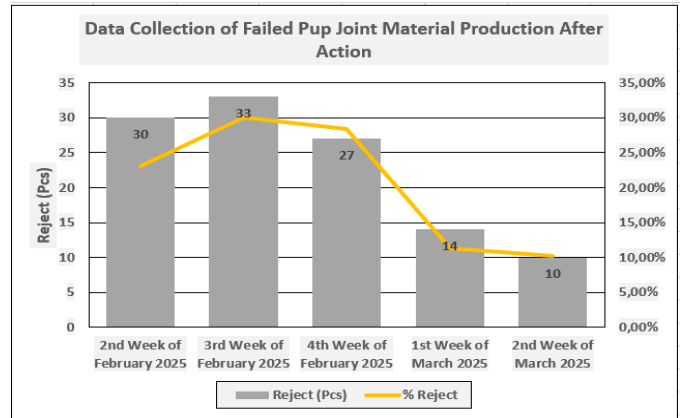
**Figure 13.** Production reject percentage per week After Corrective Action.

From the data collected after the corrective actions, it was found that the total production failures during the five-week period (early February to early March 2025) had the highest percentage in the third week of February 2025, at 30.00%, and the lowest in the second week of March 2025, at 10.20%. The average percentage of production failures per week before the corrective action, measured prior to this five-week period, was 20.47%. This demonstrates a decrease in material rejection issues in the production process of flaring joints on the stress relief machine, as evidenced by a decrease in the percentage. This suggests the corrective action was successful, and the company must consistently apply this method to prevent a recurrence of these problems in future production cycles.

Based on the Pareto Diagram in Figure 13, after corrective actions were taken, shows a significant decrease in the number of rejected products and the percentage of rejects in the production process during the five weeks from the second week of February 2025 to the second week of March 2025. With the highest number of defects in pup joint production in the 3rd week of February 2025, amounting to 33 pcs, and the lowest number of defects occurring in the 2nd week of March 2025, amounting to 10 pcs, the results of this data indicate that the corrective actions taken were successful in reducing the level of defects in the production process.
