Comparison of Harbest and Master Harness Methode For Analyzing Defect Wire Harness Product on Toyota Alphard 812888-XXX

Final Project

**Electronics Manufacturing Engineering Study Program
Electrical Engineering Department
Politeknik Negeri Batam
2024**

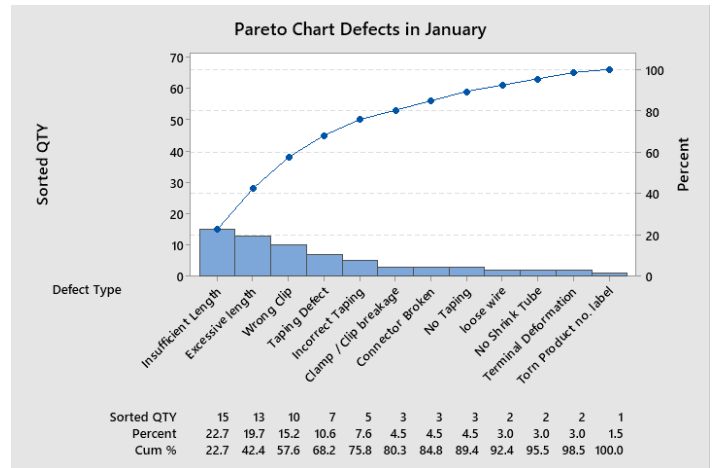
Figure 10. Diagram Pareto Chart

The following is a graph of the defect data in January obtained using the master harness checking method and processed using a Pareto diagram. The diagram can be seen in Figure 10.

Based on the pareto diagram shown in Figure 9, it shows that the type of defect that often occurs is the Insufficient Length problem with a total of 15 defects or 22.72%. Furthermore, the second frequent type of defect is Excessive Length with a total defect of 13 or 19.69%. Furthermore, the third frequent defect is Wrong Clip with a total defect of 10 or 15.15%. From this value, a percentage of 22.72% of the total 100% number of defects is obtained through the use of the 80/20 Pareto method, where the percentage value that exceeds 20% is the main requirement in finding solutions to reduce defects.

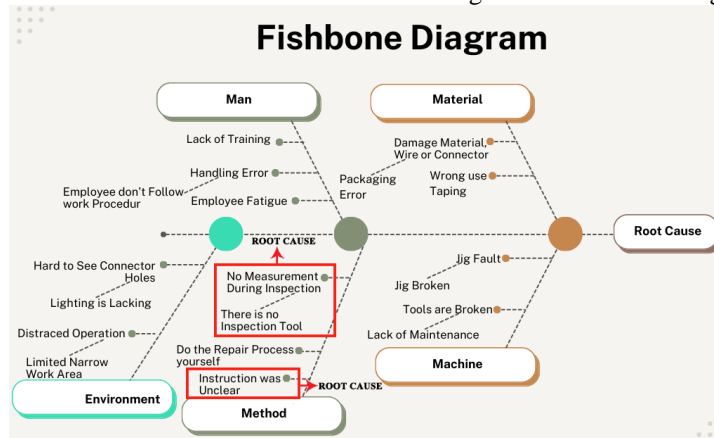
Figure 11. Fishbone Diagram

The following is a causal diagram to analyze problems that occurred before on the Pareto chart. The fishbone diagram can be seen in Figure 11.

From the fishbone diagram in Figure 10, it can be seen some of the defect influences that cause the passing of checks and the occurrence of Insufficient Length in wire harnesses.

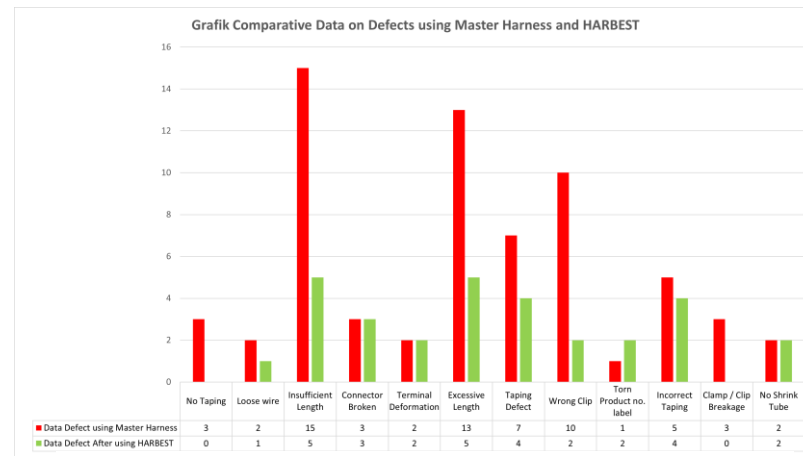
Figure 12. Bar Chart Comparative data on defects using Master Harness and HARBEST

Comparative Analysis Data is in this study comparing defect data collected by the Master Harnes and Harness Best Engineering System (HARBEST) methods. The comparison data can be seen in Figure 12.

The Comparative Data Analysis Bar Chart provides a comparison between the data collected using the Master Harness method and the data collected using the Harness Best Engineering System (HARBEST) method to compare the passing defect data from both methods. This data helps in identifying the differences and improvements achieved by implementing the Harness Best Engineering System (HARBEST) method.

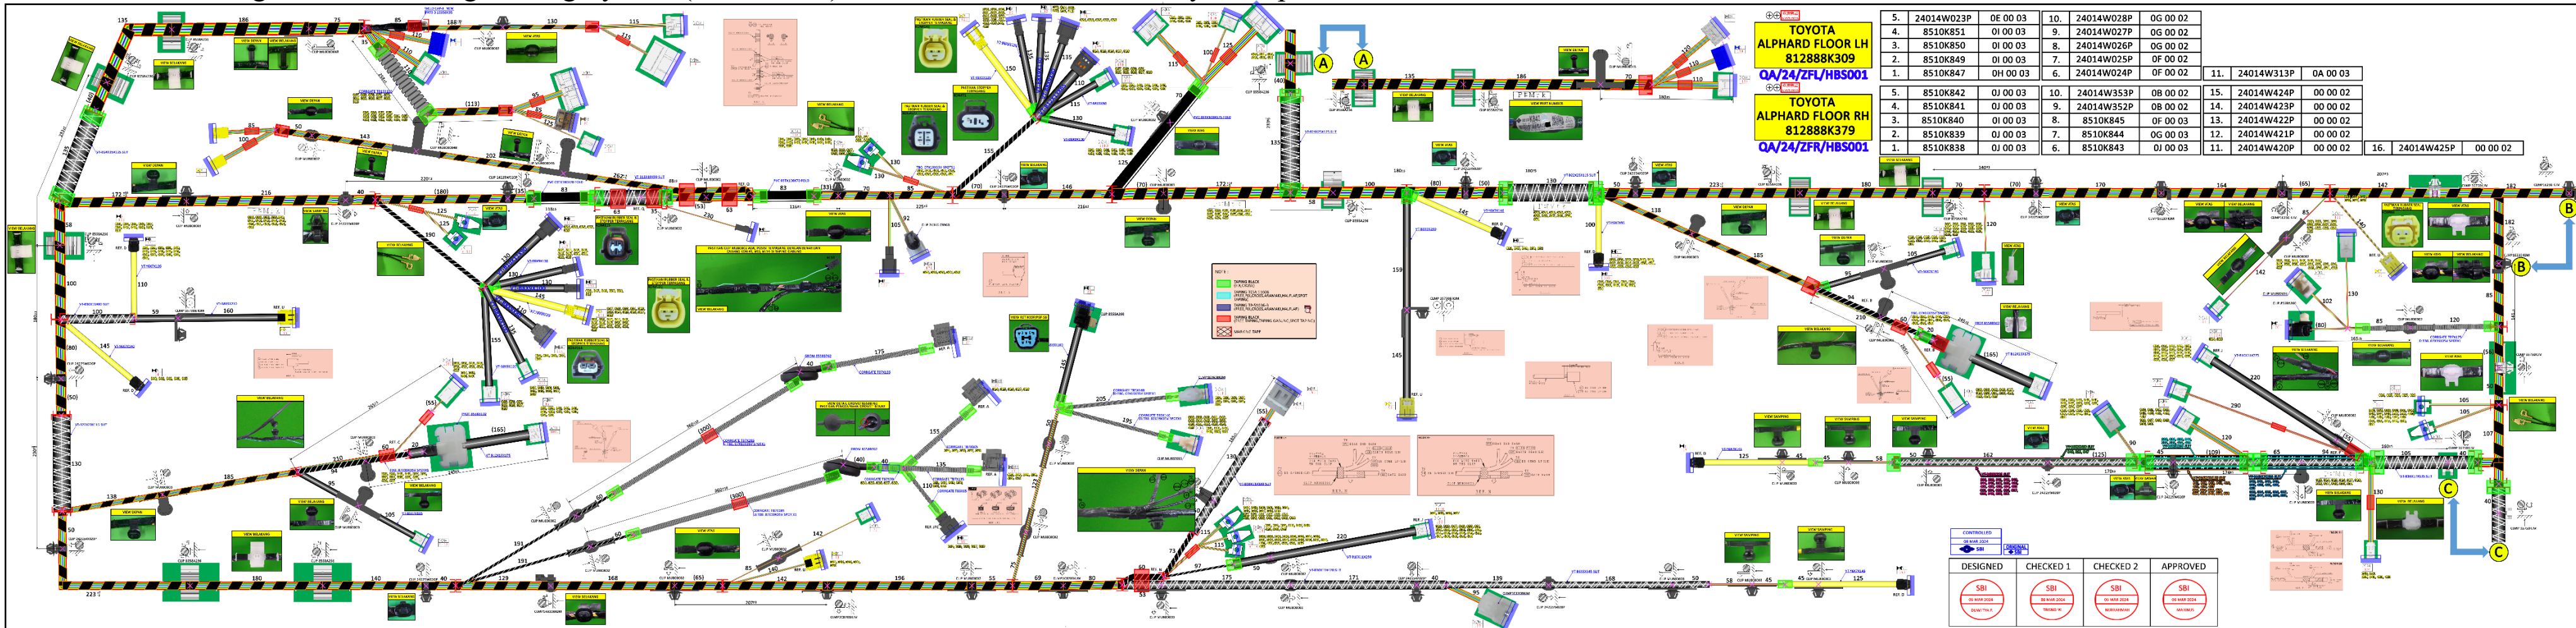
• Drawing Harnes Best Engineering System (HARBEST) Product Wire Harness on Toyota Alphard 812888-XXX
