# **ANALYSIS OF NEEDLE PIN ADAPTER DYNAMICS IN THE IGBT MODULE ENDTEST PROCESS**

## **Final Assignment**

**Electronics Manufacturing Engineering Study Program  
Electrical engineering major  
Batam State Polytechnic  
2024**

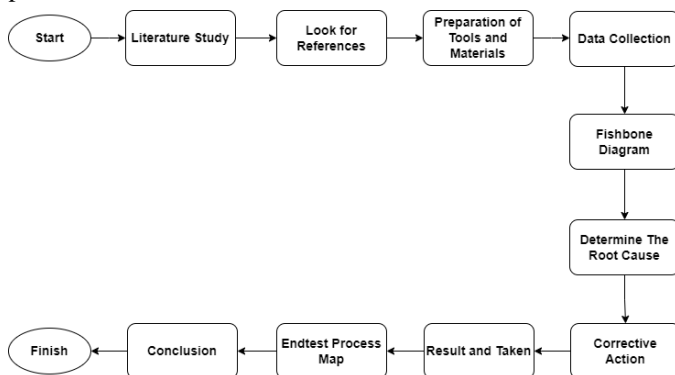
Figure 1. Planning Flow

In carrying out analysis on needle pins, the author needs to create a flow chat to make it easier to plan and be able to carry out analysis in a structured manner. The process steps can be seen in Figure. 1. Make plans in a structured and systematic manner so that improvements can be made with organized guidelines and can make it easier to observe problems that occur.

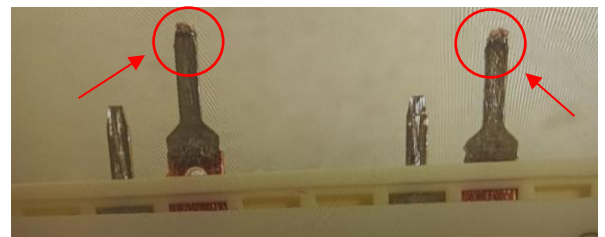
Figure 4. The Pin Lifted and Burned

Needle Pin needs to be confirmed in condition before testing the module. Burned and jammed needle pins occur because the module pins are dirty. This research will analyse common problems, one of which is burning pins and what factors cause burning pins. This will simplify testing schedules, downtime, and daily throughput. With so many resources available, these three processes need to be considered so as not to cause waste of all production resources.

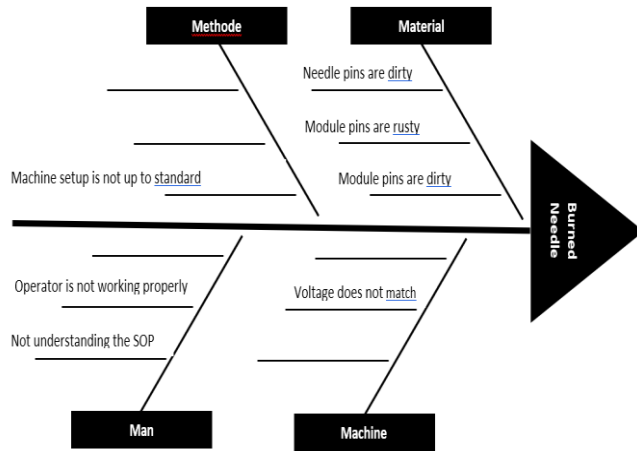
Figure 8. Fishbone Diagram

Based on the results of interviews with the company and field observations carried out by operators, technicians and technologists, several problem factors that occurred with the

dynamic pin adapter, especially on the Endtest machine for producing IGBT modules, were obtained. The author summarizes the root of the problem in the form of a fishbone diagram.
